REPORT ON STUDY VISIT

IN JANOWIEC CASTLE, POLAND

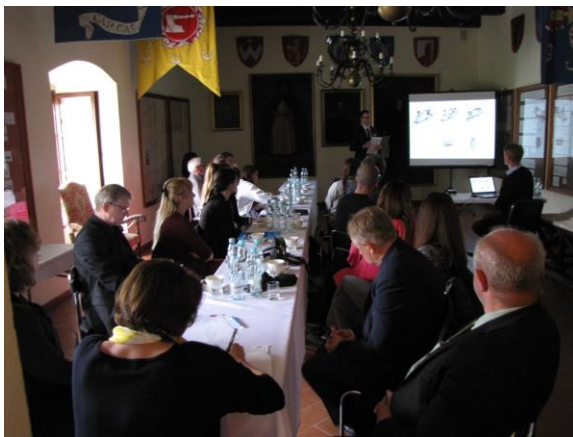
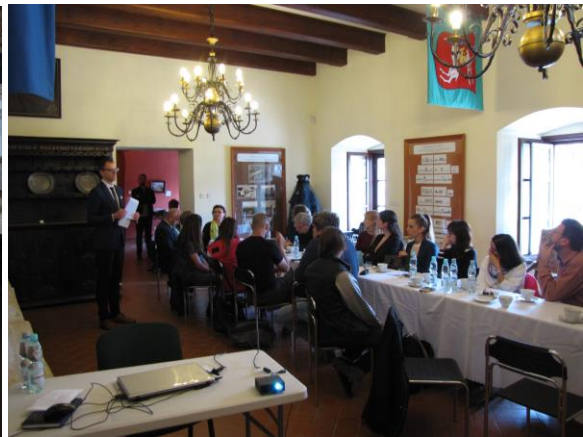
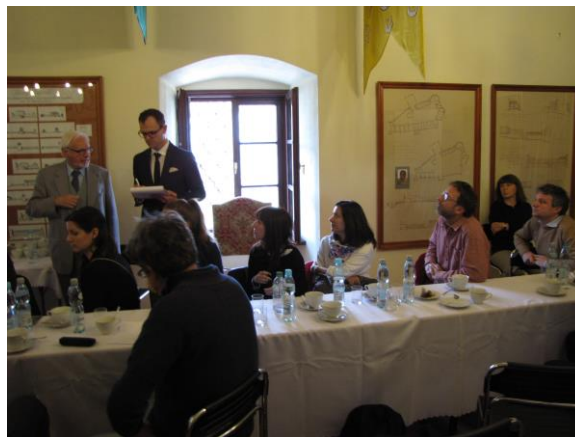
Part II: Presentation of technical condition of the ruin in Janowiec and examples of conservation and technical works carried out in ruined castle in Janowiec – in situ survey

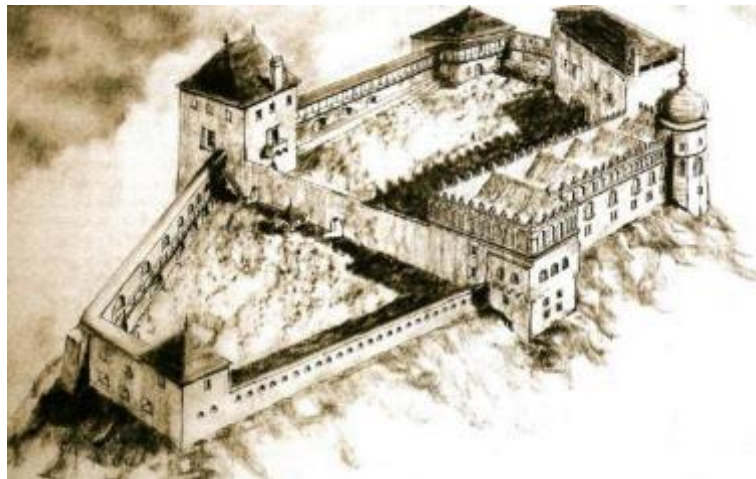
Drawing3 The castle and what it might have looked like in the late 1670s, facing the south-west. Drawing by T. Augustynek, 1994.

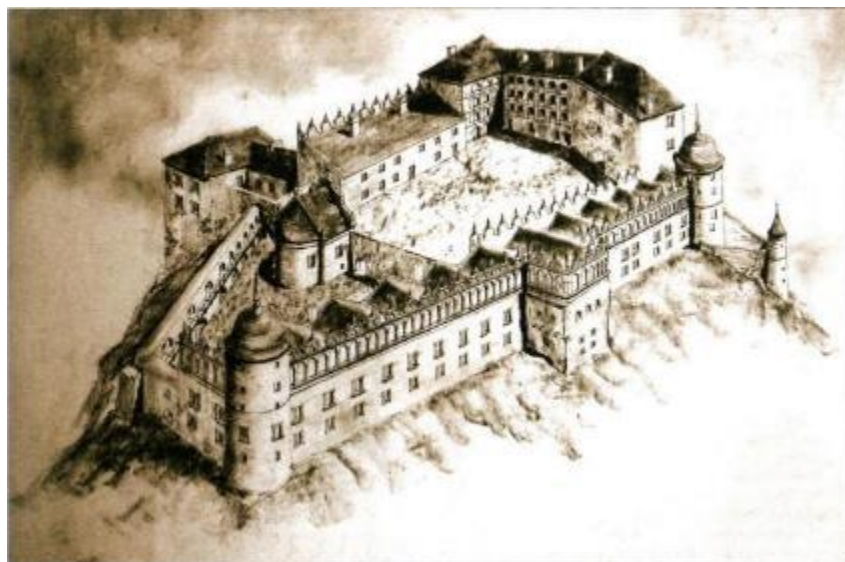
Drawing 4 The castle and what it might have looked like in the third quarter of the 17th century, facing the south-west. Drawing by T. Augustynek, 1994.

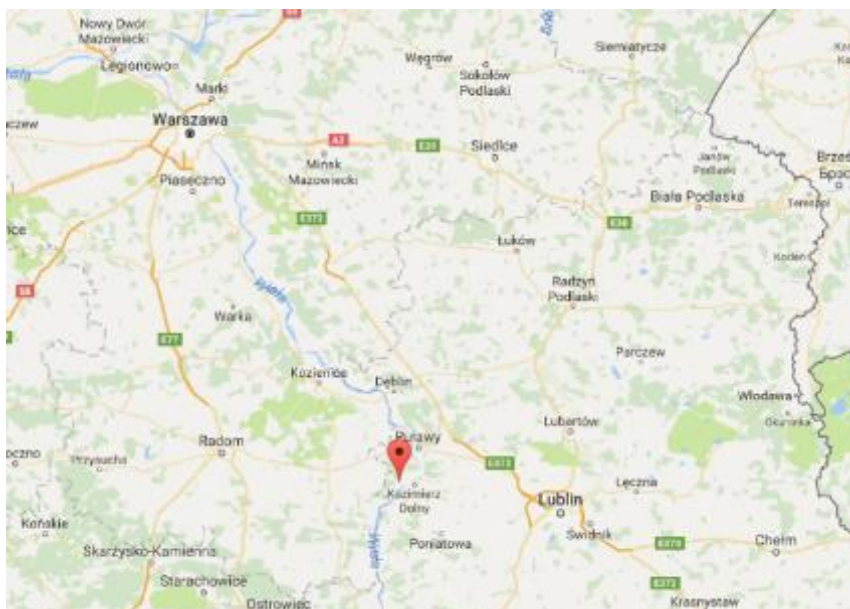
Picture 6 Location of Janowiec (source: maps.google.com)

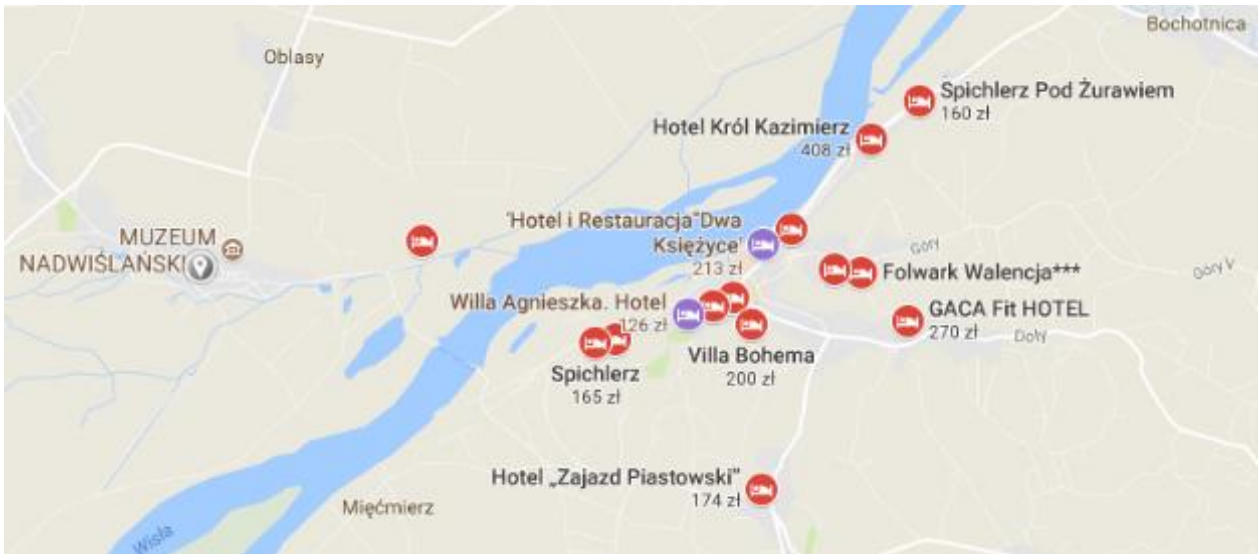
Picture 7 Accommodation in and outside Janowiec (source: maps.google.com)

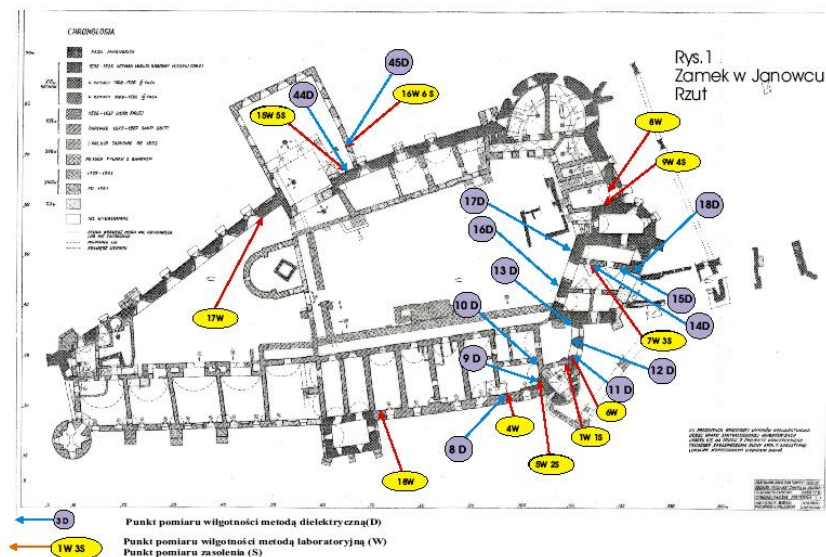
Picture 10 Place of sampling for the study of moisture and salinity at Janowiec Castle.

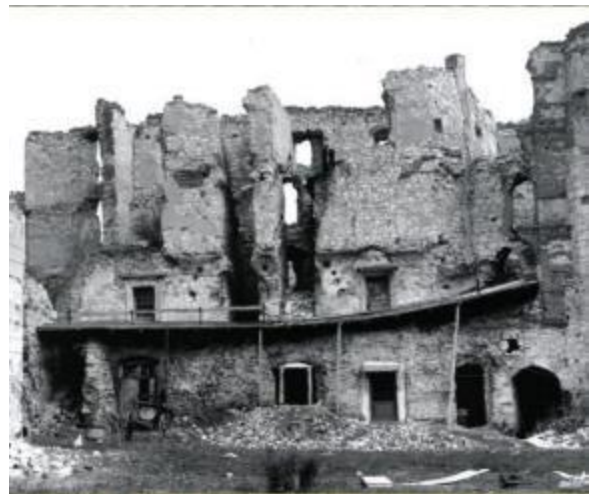
Photo 45 East wing in 1976, overlooking the Grand Courtyard. Photo: J. Żurawski, 1976.

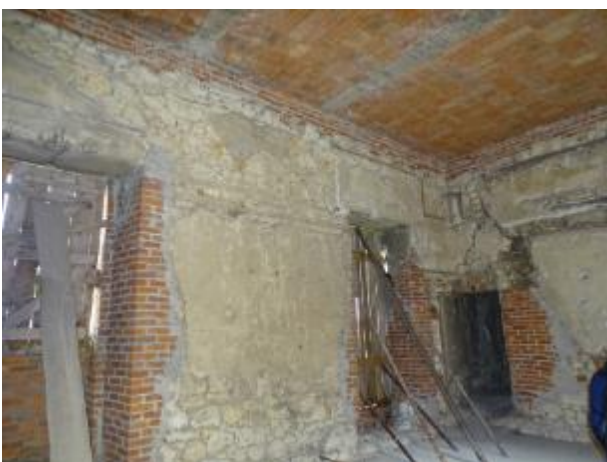
Photo 61 Repairing walls with ceramic solid brick - non-original material

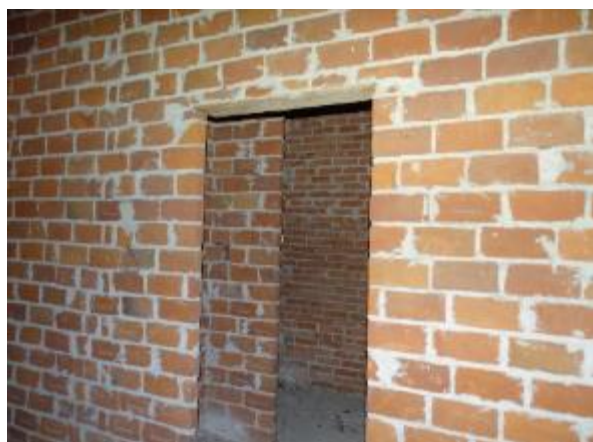
Photo 61 Dividing walls made of ceramic solid brick - non-original material

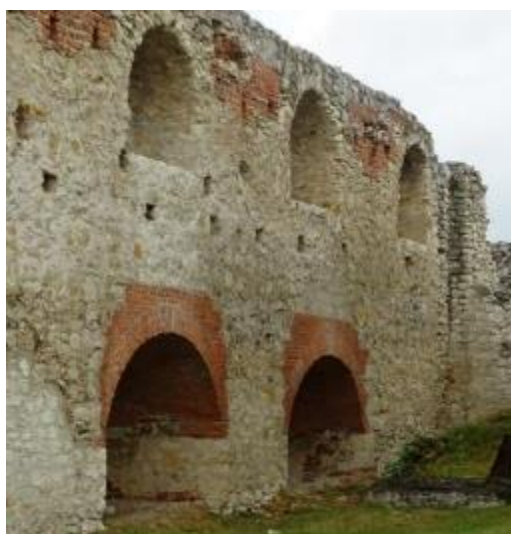
Photo 62 The north wall: repairing the face of the walls from the inside of the building

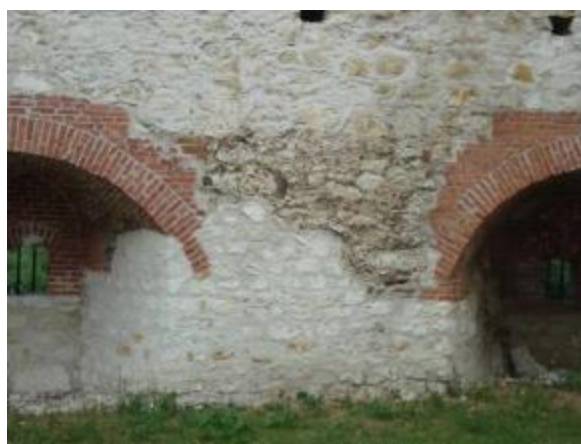
Photo 63 The reconstructed and the original parts of the north defence wall.

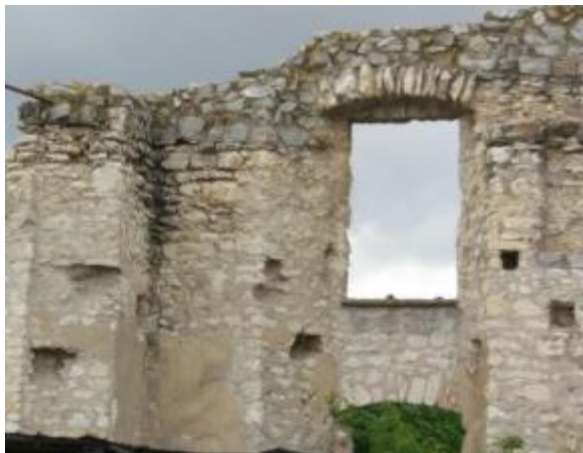
Photo 64 Wall of the Servants' building - north part of the castle. The repairs made in the lower parts are in satisfying condition. The face of the wall is degraded at the junction with the calcite crown.

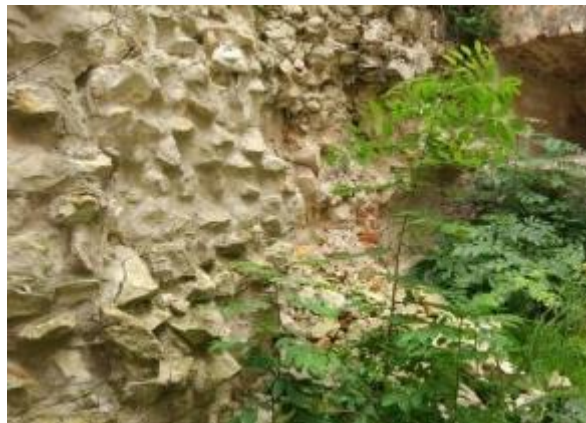
Photo 65 The wall of the Grand Bastion - north-east part of the castle Damaged part of the wall which was already a subject of preservation works.

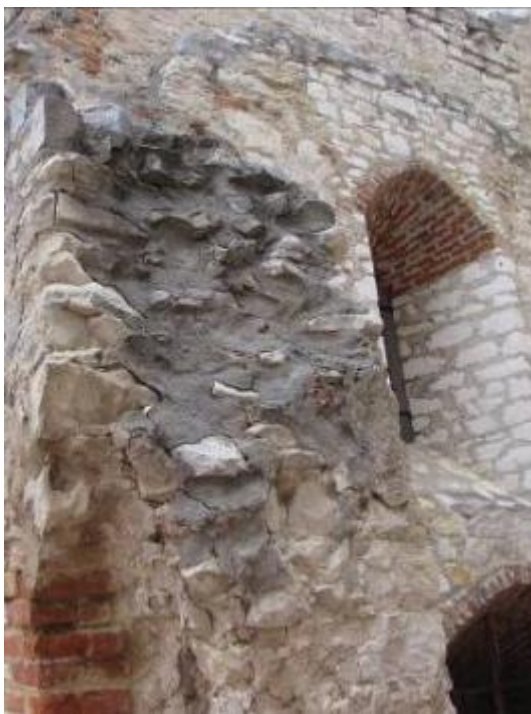
Photo 66 The wall of the Grand Bastion - north-east part of the castle Cement-based mortar used for repairing the falling-off face of the wall.

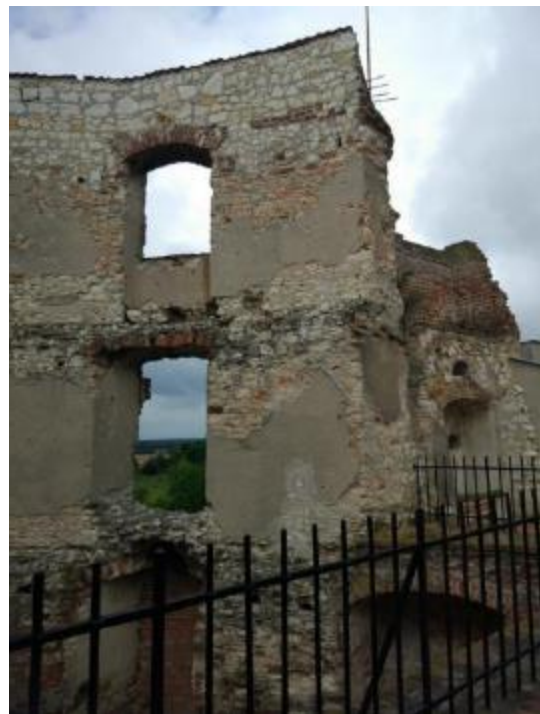
Photo 67 East tower Original parts of the walls are considerably damaged; the condition of the reconstructed upper part is satisfying.

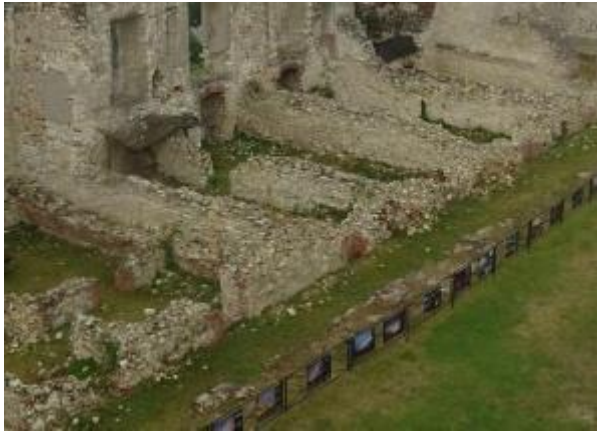
Photo 68 South suite of rooms

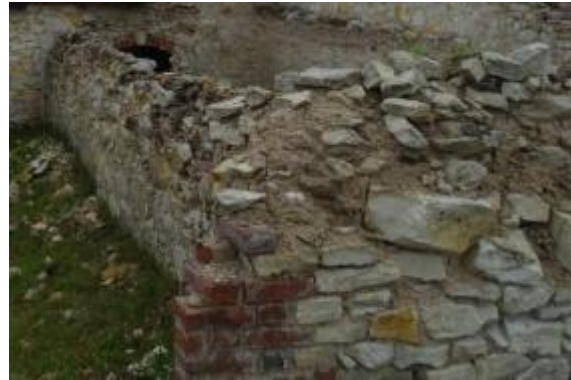
Photo 69 South suite of rooms - damaged grouts and stone and masonry material.

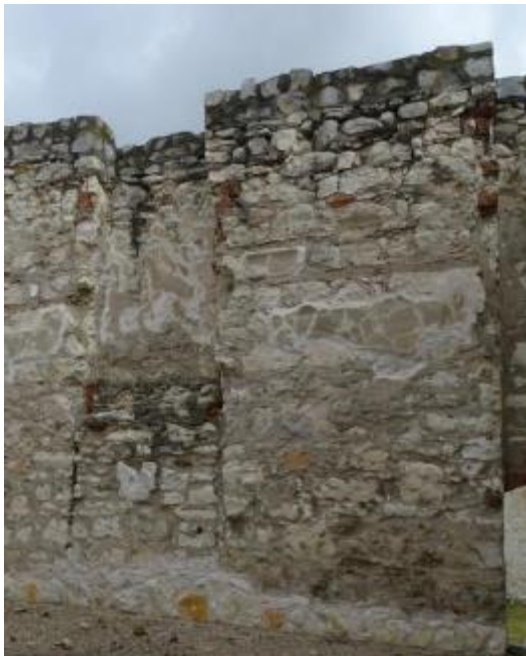
Photo 70 South suite of rooms - the face of the walls and plaster are considerably damaged where the original part of the wall conjoins the calcite coping.

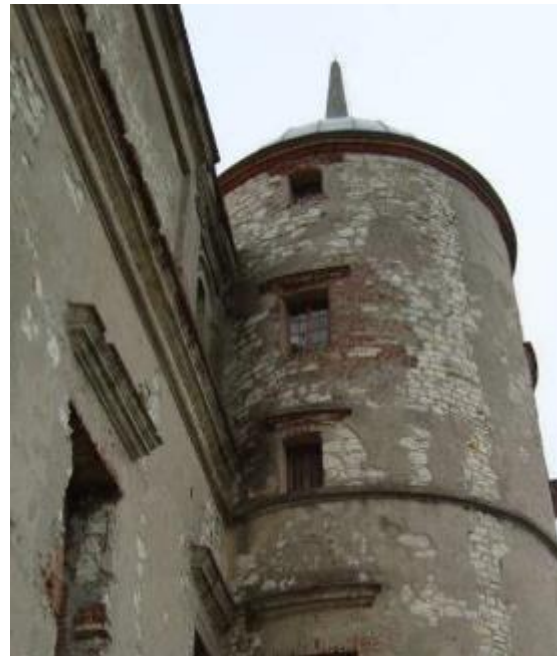
Photo 71 West tower - damp and defects on the face of the wall where the tower conjoins the west wing.

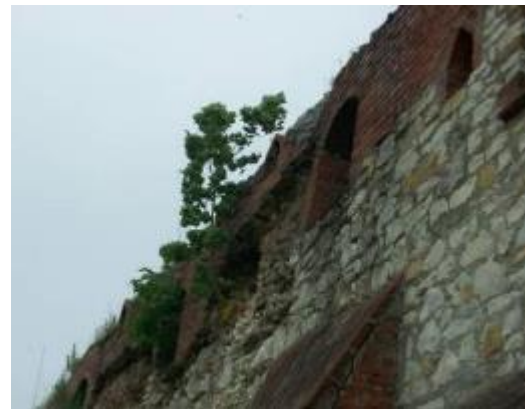
Photo 79 Adding a new layer of native material to the existing masonry; no roofing provided

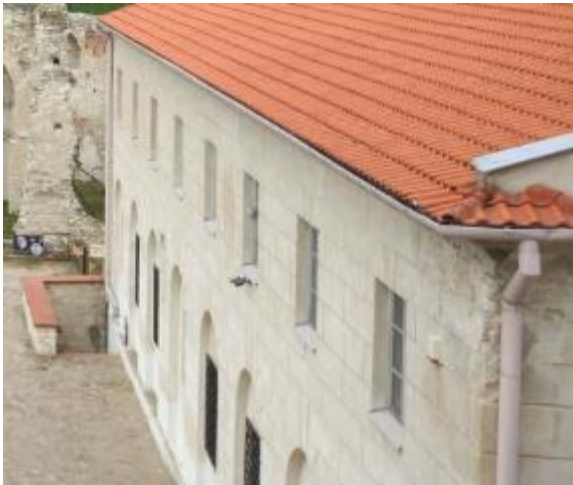
Photo 80 Leaky elements of the drainage system result in the corner of the building being damaged.

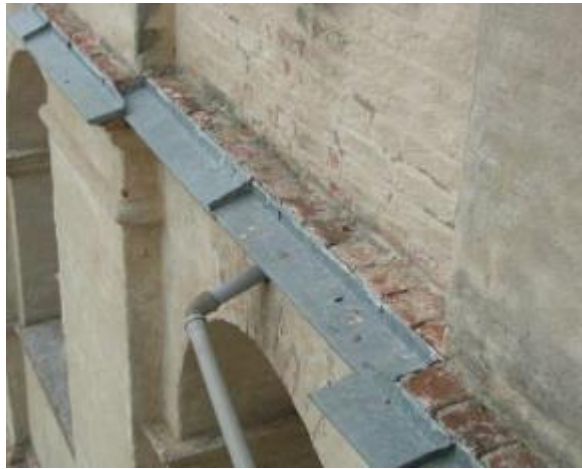
Photo 81 Metal elements fail to cover the cornice

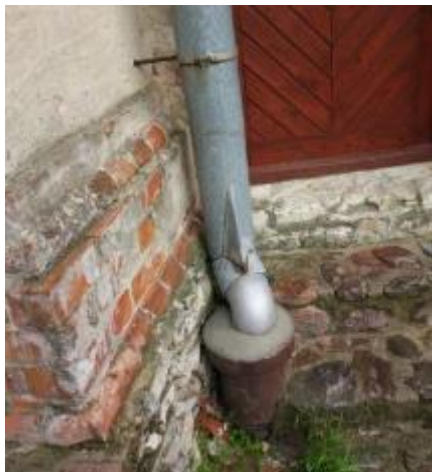
Photo 82 Outlet pipe connected to the storm drain system

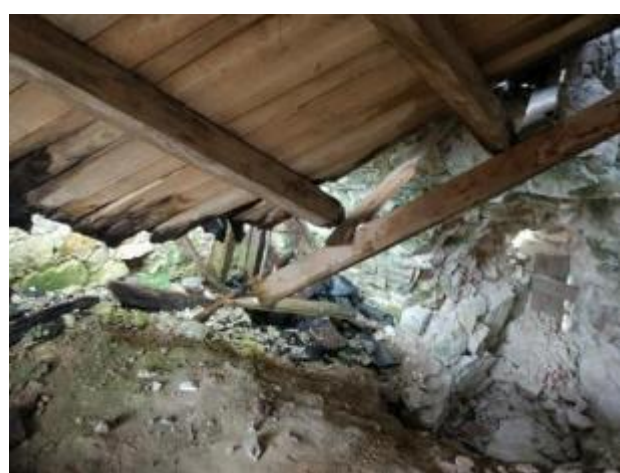
Photo 89 Damaged roofing which covers the basement of the south suite of rooms

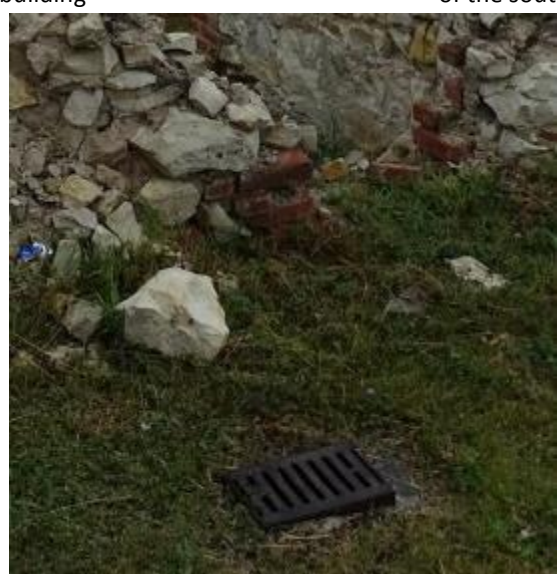
Photo 90 Drain grate located above grade

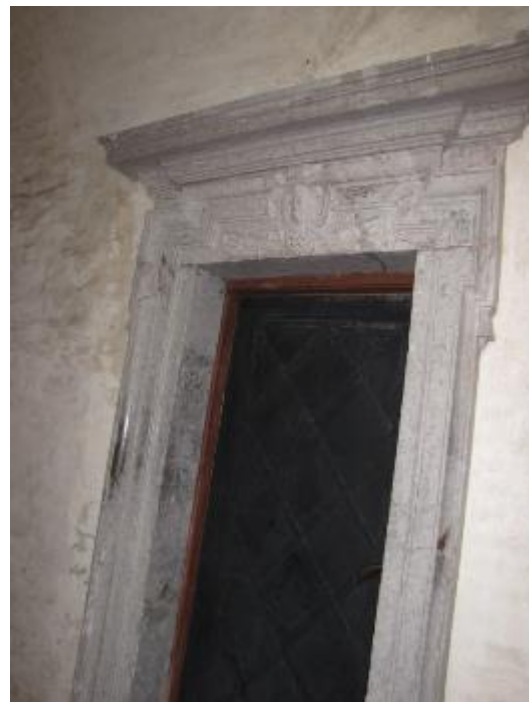
Photo 92 Baroque-style marble portal; first floor in east wing

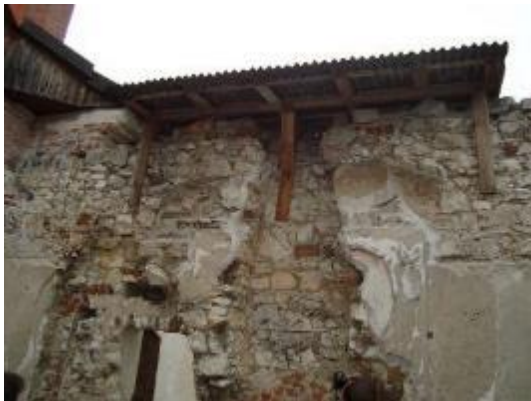
Photo 93 South arcades: roofing above moulding

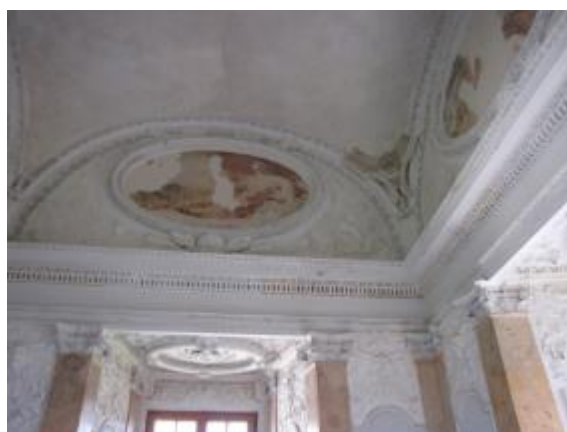
Photo 97 West tower room: moulding after conservation works

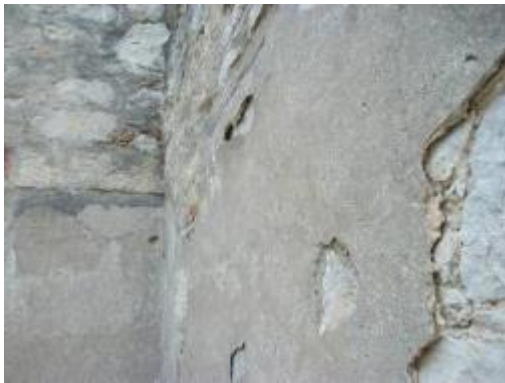
Photo 102 South suite of rooms: condition of the plaster

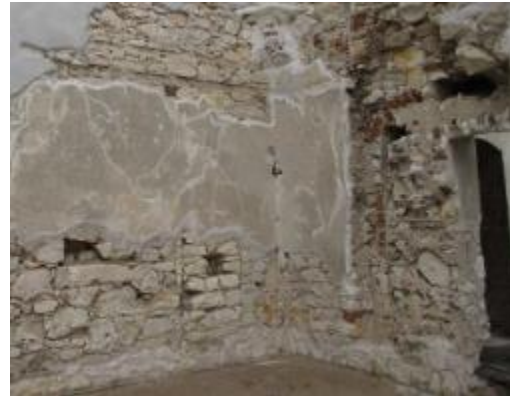
Photo 103 South suite of rooms: plaster protection

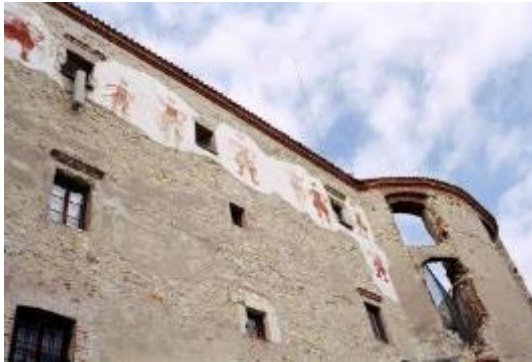
Photo 104 Reconstructed sgraffito frieze depicting halberdiers

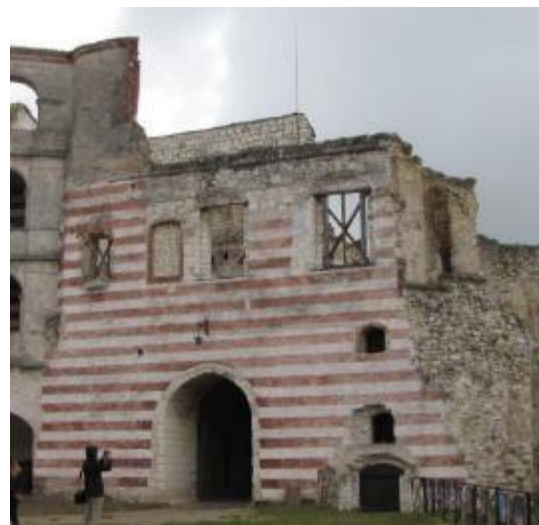
- **Sgraffiti and polychrome paintings - condition assessment**

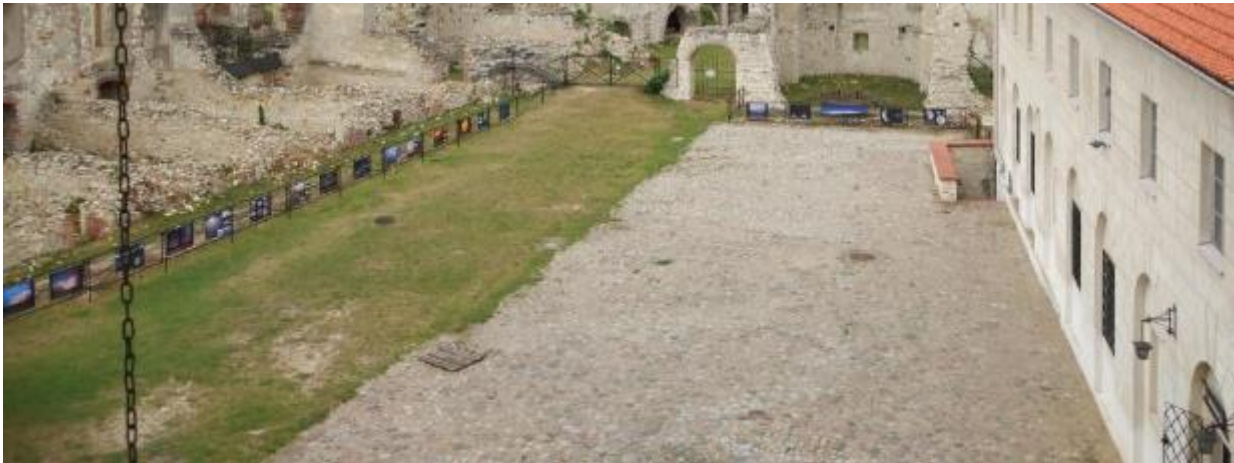
Photo 107 The grand courtyard

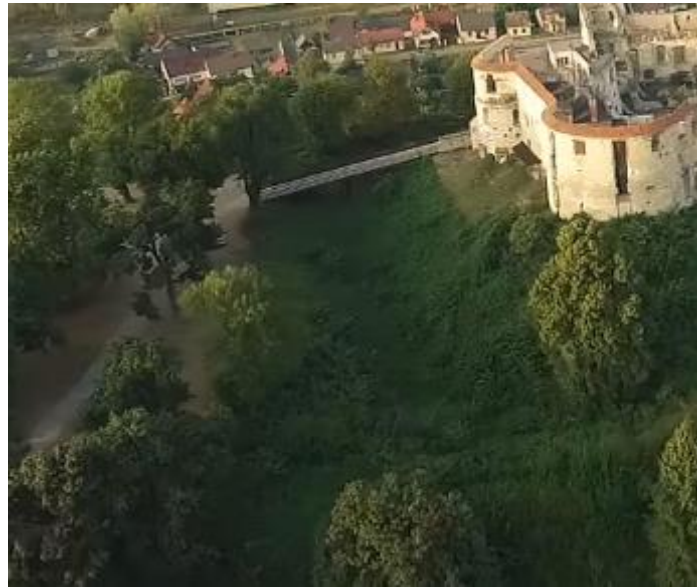
Photo 112 Castle moat

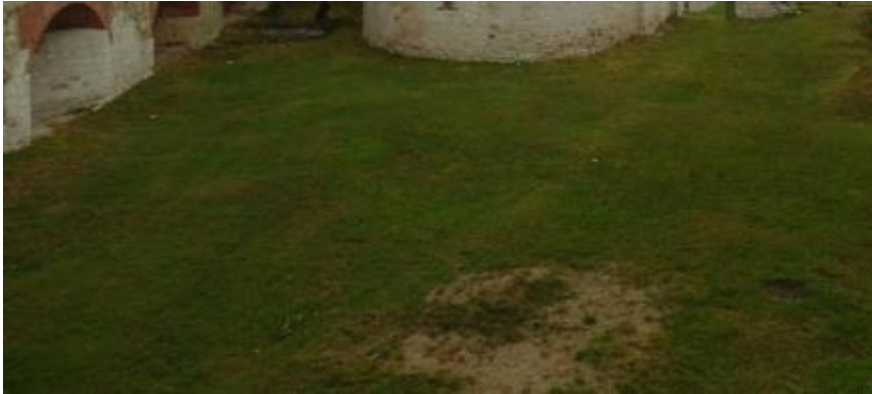
Photo 114 The grand courtyard

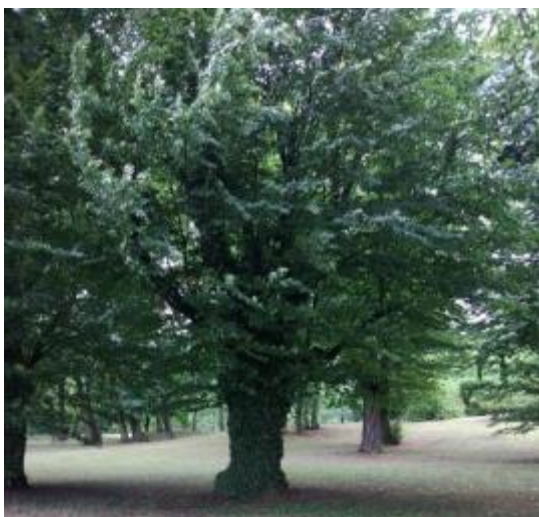
Photo 120 Ancient forest between the manor house and the castle

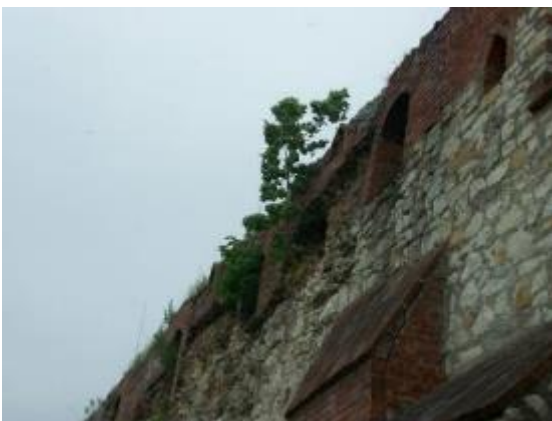
Photo 124 Young trees on the north wall coping
