RUINS

REPORT ON STUDY VISIT

IN st. STOŠIJA church in ZADAR, CROATIA

REPORT ON STUDY VISIT in St. Stošija Church Puntamika Zadar

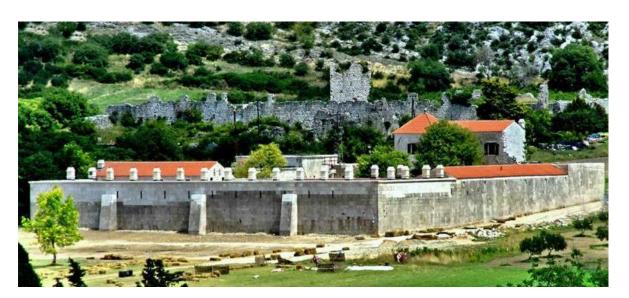
Han is extremely monumental and representative building of a rectangular shape, surface area greater than 3000 square meters. It was built as a fortress and built of finely cut stone blocks.

The interior is divided into two parts: the larger intended for placement and hosting traveler and somewhat smaller, which was probably the residence of the owner Yusuf Maškovića. The Han is entered through a gate established on the ground floor of the main residential

building. Opposite the entrance is an open pavilion – a fountain – dissolved arches, under what used to be a fountain of water. On the south wall is located down the dormitory – and each room had its own fireplace. In contrast to the houses, are the remains of outbuildings and swimming – hamam. On the peripheral wall of a small courtyard has been preserved down the niche – the fireplace which alternate in a regular rhythm with narrow openings loophole. Islamic construction element in particular is recognized in the form of arches that are sharp, built very precisely cut stone.

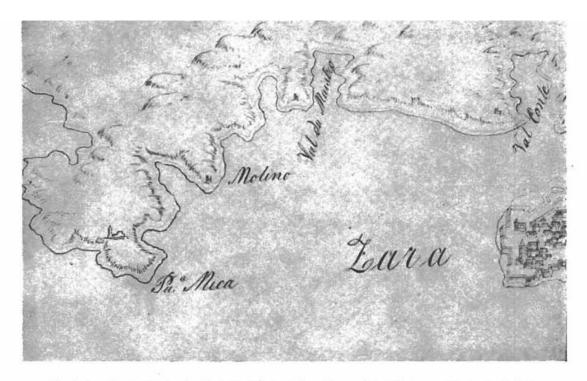
Sl. 1. Kopija karte iz 1675. god. Na Puntamiki se vide ruševine crkve sv. Stošije

Picture 1.: Copie of the map from 1675. On the Peninsula of Punta Mica the remains of the Church of st. Stošija are visible.

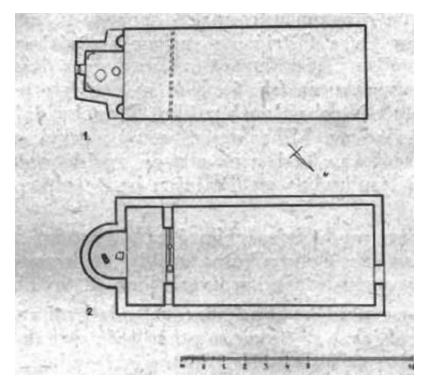
The Ruin in question is a two storey building created by renovating the Roman residential-commercial complex's (villa rustica) cistern. In it, a rectangular, i.e. trapezoidal apse with angular niche and semi calotte was annexed. The upper church was erected on the cistern's arch. Its basis is 6,50 m wide and 13,50 m long. A semicircular apse leans on it thus creating an unusual shape of a two storey church with the lower storey having almost the same dimensions as the upper one.

Drawing 1.: 1. The layout of the lower church, 2. The layout and possible reconstruction of the upper church⁹..

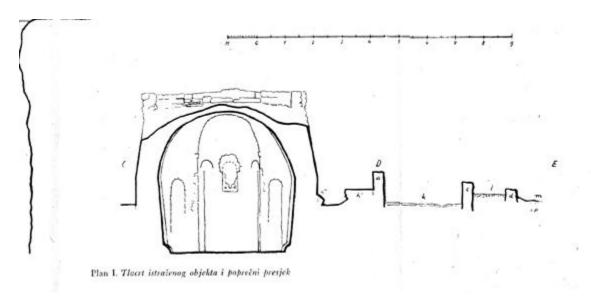
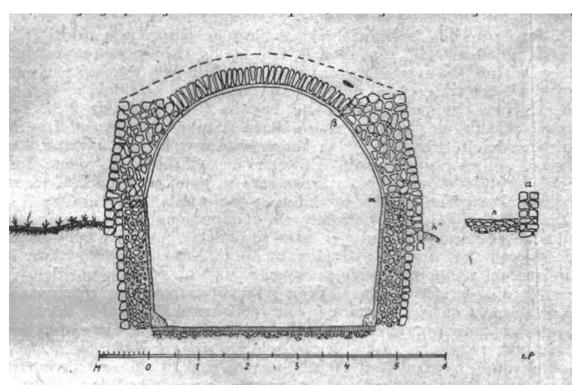
The primary object of the Ruin is the Roman Cistern with the barrel vault. It was buried in the ground, as it was the Roman tradition for this type of construction. Its length is 16, 10 meters, the width is 6,5 meters and the interior height is 4,90 meters. The interior walls all have a fine mortar coating to ensure the waterproofness of the cistern.

Drawing 2: Floor plan and cross section 10./Drawing 3: Cross section trough the Cistern.

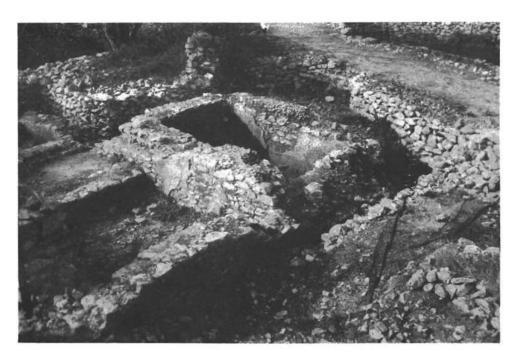
Along the side of the walls a and b^{11} of the principal cistern tank there is a smaller water cistern with the length of 2,68 meters and the width of 1,70 meters and the preserved height of 1 meter. The characteristics of this smaller tank are exactly the same as the wider one, more precisely, the walls are all covered in fine mortar cover with a mixture of pounded bricks and the floor is covered with fine pieces of red bricks assembled in typical roman pattern (opus isodomum)¹².

Picture 2.: the smaller Cistern-Lacus Balinearium¹³.

The function of the smaller cistern stays unknown but the placement and the size of it could indicate that it was used as *lacus balinearium* or a cistern for a bath¹⁴. Furthermore the remains of some mosaic decorations found in the smaller rooms on the site broth us to the most plausible conclusion that all the roman elements found during the archeological excavation belong to the roman complex of a considerable Roman Villa (Villa Rustica) build by the landowner of the adjacent fields.

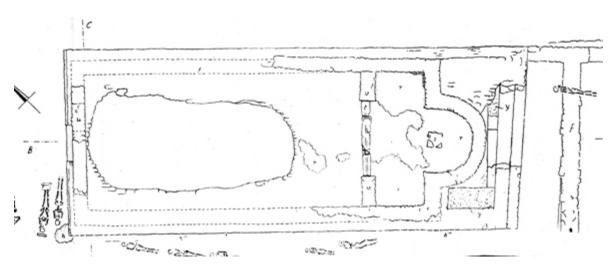
The early Middle Ages addition to the cistern consists of altar elements represented by the square apse and adjacent walls with niches. Regarding the fact that the importance was to meet the practical needs of the cult and that the original roman structure dictated the organization of further elements, the architect of the additional structures wasn't concern by the external aspect or the regularity of the apse. The vault of the apse is a semi dome and the transfer from the square apse to a dome was done by using the squinch or a construction filling in the upper angles in order to form a base to receive a dome.

Plan 1: The apse of the early middel ages, lower level 15.

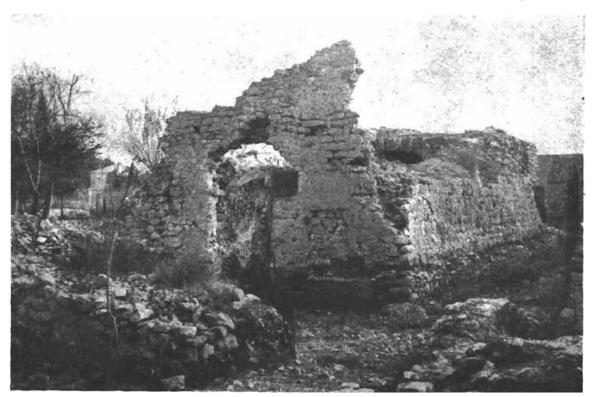
Picture 4: West fasade of st, Stošija church in 1952¹⁷.

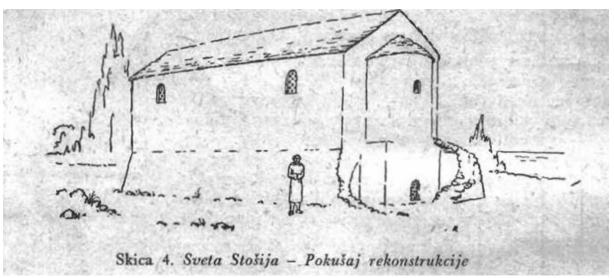
The mentioned elements found during the archeological excavations and their further analysis broth to the possibility of rather exact ideal reconstruction of both structures. The lower church used the roman cistern's space. It had a barrel vault, large entrance space that was the most important source of natural light. The small window and a trenzena in the lower church's apse could lighten only the altar. The passage from the entrance to the floor level of the lower church could not be reconstructed because of the lack of archeological remains. The upper church did not communicate with the lower one. It had its own entrance on the left of the lower church entrance. The stairs for the upper level weren't conserved so we can presume they were made out of wooden material. The altar barrier of the upper church wasn't symmetric and from both sides it was connected to two wall pillars on the longitudinal wall (1 meter from the surface of the wall). Altar cavity stood on the walled column and had a semi-circular apse with, presumably at least one opening.

Picture 7: Possible reconstruction of two churches.

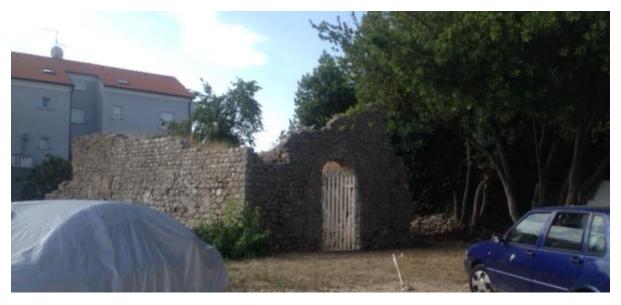
Picture 10:August 2017. Cars parked in front of the principal entrance to the church of st. Stošija.

The placement in front and around the church is frequently used as a parking place and boat discharge. There is no information board with the name of the church and the importance of this monument. However there is a knowledge about it that is kept and transmitted by the local population. Ms. Bruna Supičić from the association *Prijatelji Puntamike* (Friends of Puntamika) and all the native born are, on their free time and good will, taking care of the church considering it as theirs and a sacral place that needs to be taken care off.

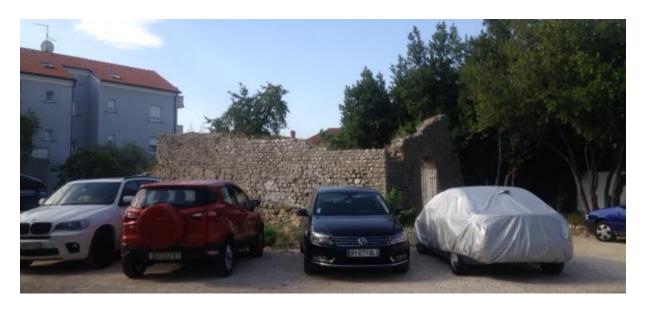
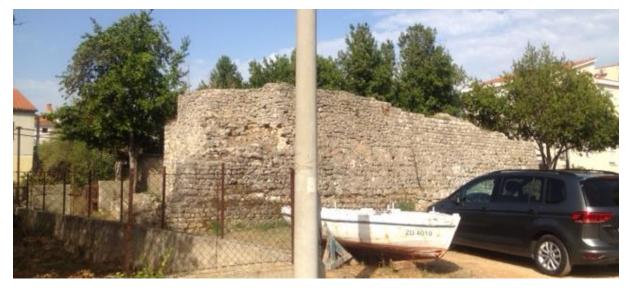
Picture 11., 12.,: August 2017. The presence of cars adjacent the wall of historic monument.

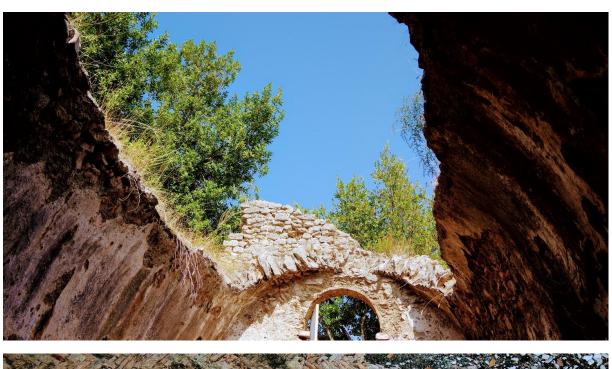
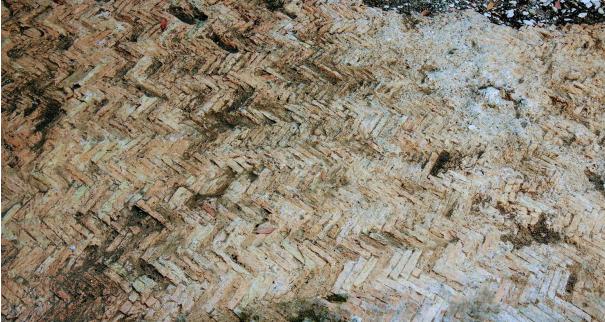
Moisture and temperature changes have been identified as a reason for substantial damage or failures at historic monuments²⁴. The moisture and temperature levels are elevated and not optimal due to number of existing structural damages to the monument and close presence of urban constructions, visitors and vehicles. The impact on the monument is a result of simultaneous actions of all mentioned environmental aspects, together with other physical and chemical conditions. There are few known studies that have been done of serious failures caused by moisture and temperature changes on other European historical monuments, but on the st. Stošija church in Puntamika that type of scientific studies didn't take place all though the damages are clearly visible and important.

The roof of the lower church (partially visible Picture 5 page 20.) is completely missing which leaves the church's interior without any protection causing considerable damage to the walls and the up to now well preserved roman floor with red brick coating (see picture 16).

Picture 13 and 14: Study visit in Zadar, august 2017

The elaboration of a program for the re-use, protection and management of the ruin is crucial for the moment. Next step will be the solution for the roof of the edifice as the lack of it accelerate the deterioration of the monument, especially the roman floor and it narrows the possibilities of re-use of the monument.

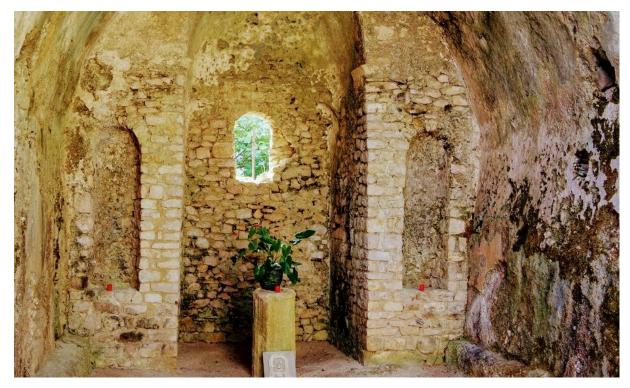
Beside the usual damages that come with time and lack of use or maintenance, there is a consequent structural disability on the present historical monument that is the principal source of further destruction.

Picture 15.: Pictures from Study Visit in Zadar, August 2017. The state of art of the monument.

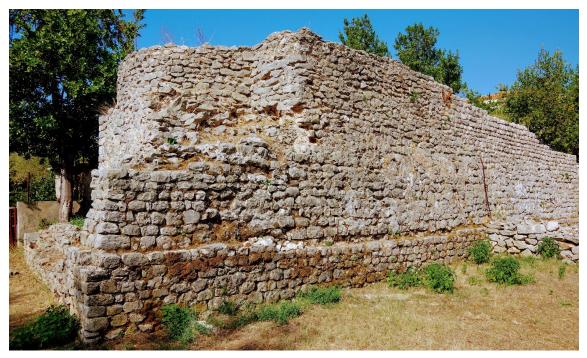
Picture 17. Study visit in Zadar, August, 2017. View on the apse of the lower church.
