DELIVERABLE D.T2.2.1

Manual of good and bad practices for disaster
resilience of cultural heritage risk
assessment.

Final
07 2018

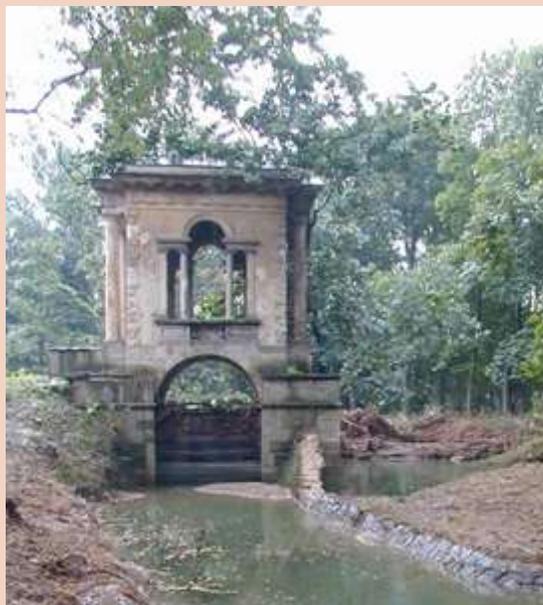
Veltrusy park, bridge (Bohemia/CZ)

Multiscale impact of water action on the historic landscape and objects

In the example, a small damaged bridge and its surroundings as a result of combined water saturation and flow in subsoil layers, typical for a sudden loss of load carrying capacity of clay or washing out of fine sand, and reconsolidation of soils loosened with uplift action. The dam on the right side has been totally destroyed and washed away.

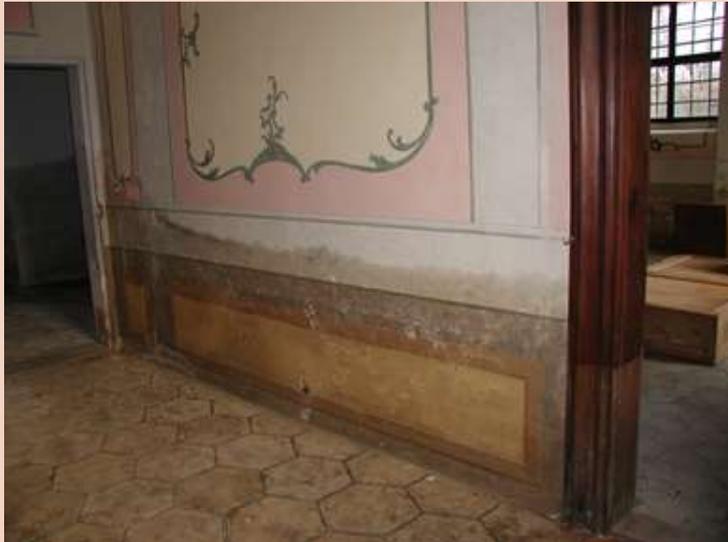
Rising damp, Veltrusy chateau (Bohemia/CZ)

Underestimation of impact of minor water flows

When drafting a correct flood risk management plan, it is important to take into consideration also events with low intensities. These may, in particular cases, induce considerable damage to cultural heritage assets. Flood water often transports various substances which may cause chemical deterioration or biological infection. In the example on the left, it is possible to see rising dampness and salt efflorescence after a low water depth flood in the Chateau Veltrusy (Bohemia).

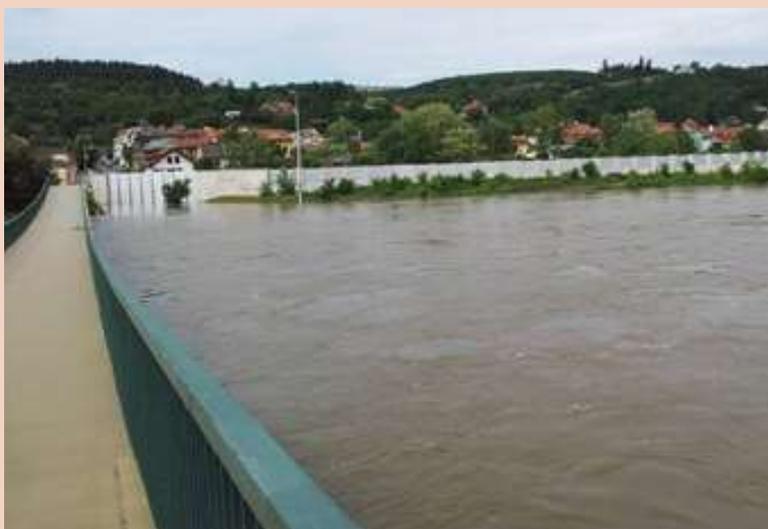
Troja (Prague/CZ)

Visual impact of structural measures in cultural heritage environments

Structural measures can have a strong impact on cultural heritage sites. For example, the protective barrier shown in the picture is highly effective during the flood situation; however, it severely changes the context between the river and the historic settlement. In this case, even if only some parts of the wall are immovable, these are still disturbing.

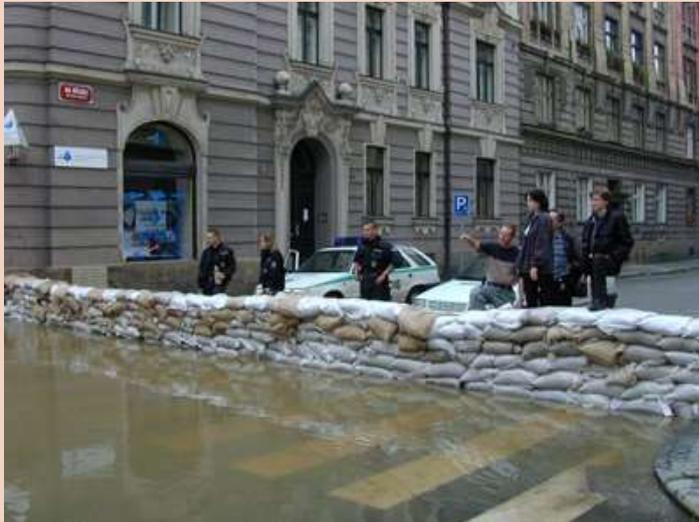
Karlín (Prague / CZ)

Evaluation of the effectiveness of emergency measures

Some emergency measures provide a relatively fast and cost effective protection against floods. However, their effectiveness can be limited and it should be always taken into consideration for each measure the safe uses that are allowed. For example, the employment of sand bags is successfully applicable only at low depth and slow velocity of water flow.

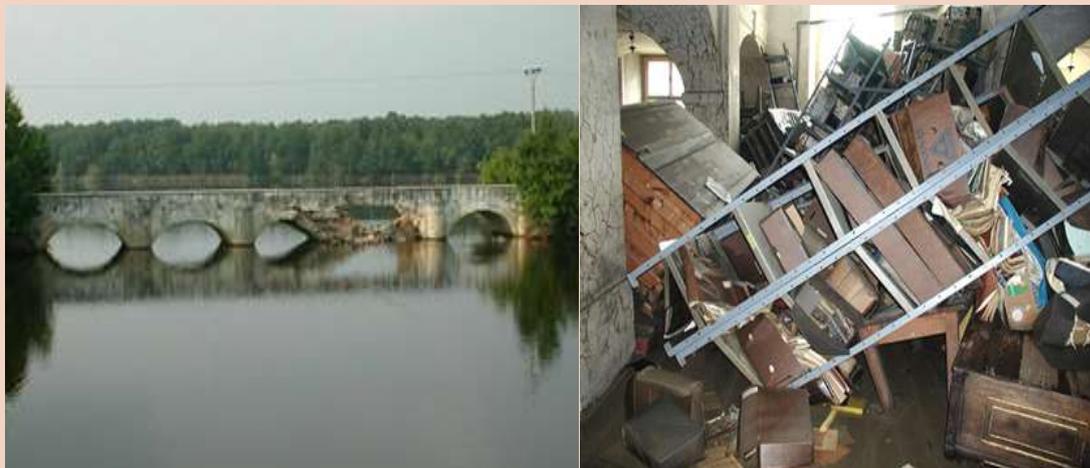
Dynamic low velocity stream action

Left: Masonry bridge in Hlína (CZ); right: archive of architectural plans NTM (Prague / CZ)

Even when measures are correctly applied, damages might occur due to dynamic action of water. Dynamic low velocity stream action is typically observed inside closed buildings where floated objects move and are displaced, e.g. furniture from one into another room; long lasting actions can even wash out subsoil under foundations or clay mortar from masonry.

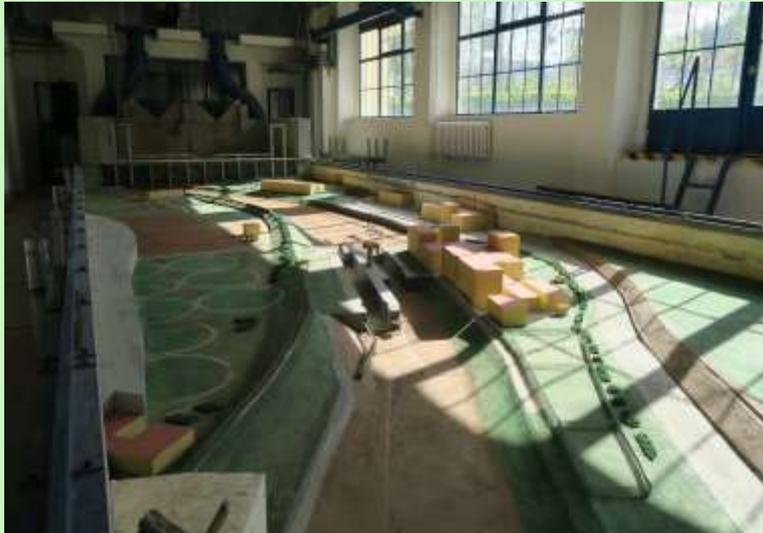
Physical model of river basin in Prague - Troja, CZ

Understanding the hazard, hydrogeological and natural processes

The behaviour of floods can be studied using physical and mathematical models which help understanding the site effects of predefined flood events. It also helps assessing the effectiveness of proposed structural measures.

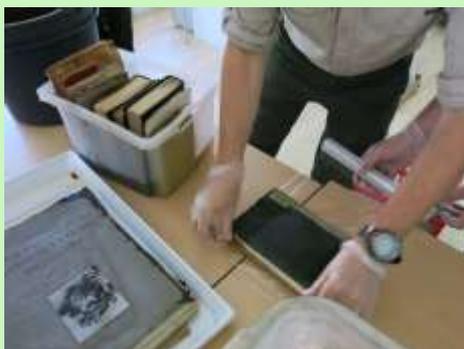
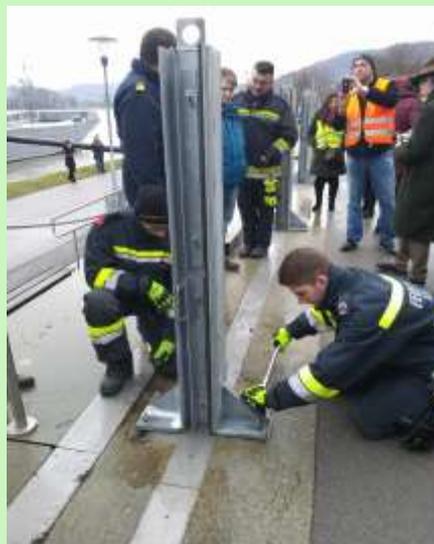
Practice: wrapping paper and books after simulated flood; right, assembling barriers

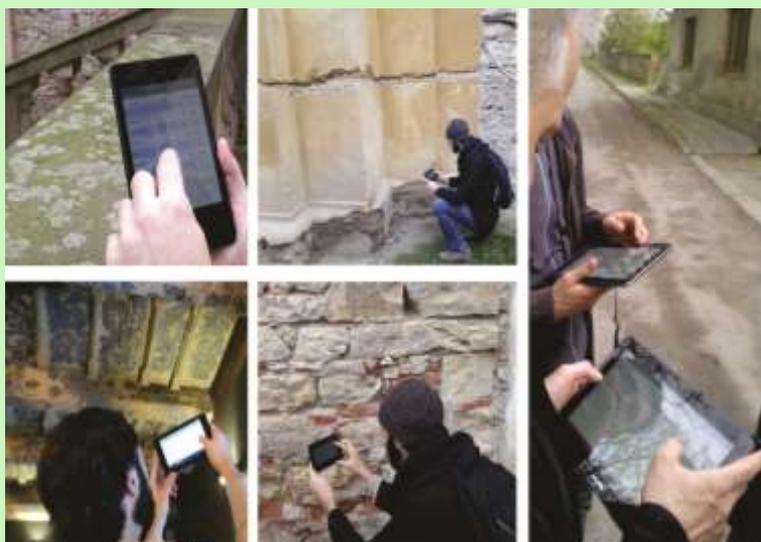
Damage identification using mobile devices (MONDIS project)

Cultural heritage mapping, identification and state of conservation

The mapping and identification of the CH assets at risk is one of the essential steps in risk evaluation and management. Knowing the location, characteristics and conditions of objects allows better planning and prioritisation. Modern ITC solutions can help to easily record and process a vast amount of data.

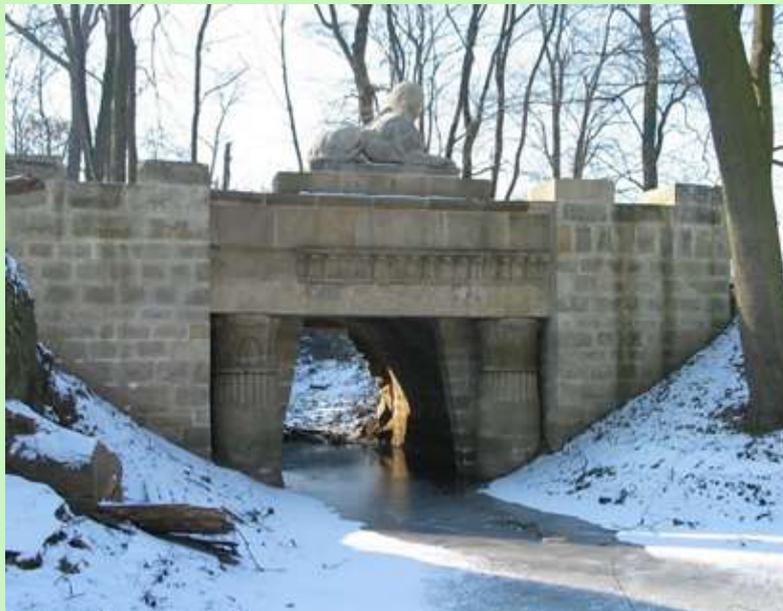
Bridge with sphinx, Veltrusy (Bohemia/CZ)

Good maintenance for resilience building

Good maintenance is key to the correct performance of structural components and materials in the event of disasters. In the picture left, a well maintained small stone bridge sustained total immersion in water during the 2002 flood in Bohemia without substantial damage and its resilience consisted only in periodic, quality maintenance (e.g. drying and surface cleaning).

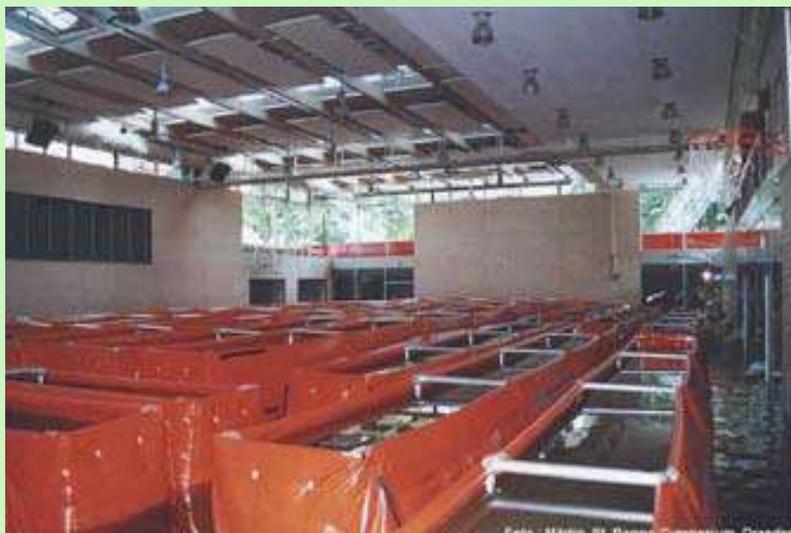
Preparedness or immediate safety works: balancing water forces

Temporary plastic foil containers filled with water prevent floor damage due to buoyancy and flow away movements in case of lightweight houses.

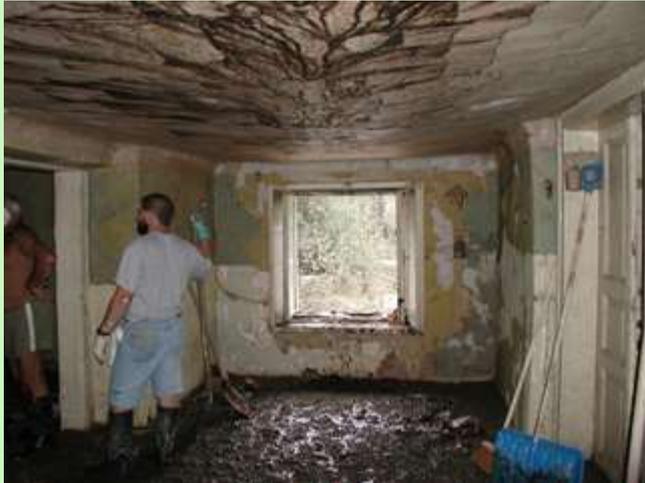
House Loskota II (Prague/CZ)

Clearing debris

Clearing debris and mud it is fundamental after flooding. In this example, a historic masonry house with a deep layer of mud on the first floor after total immersion in slowly flowing water (Prague, August 2002).

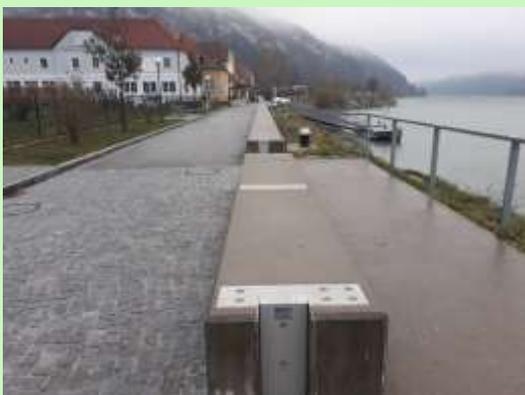
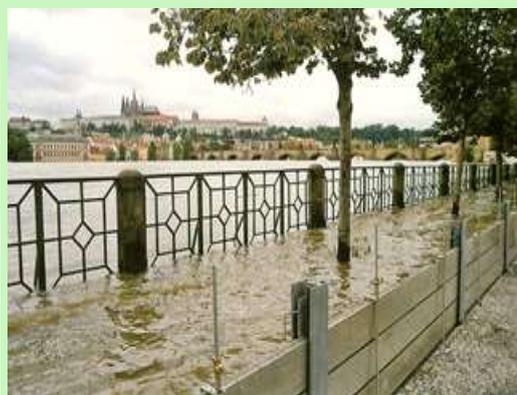
Territorial protection through the use of barriers

Left: Base wall of the protection barrier along the Danube (Spitz, Austria) ;

Right: Efficient protection in Prague during high water (CZ)

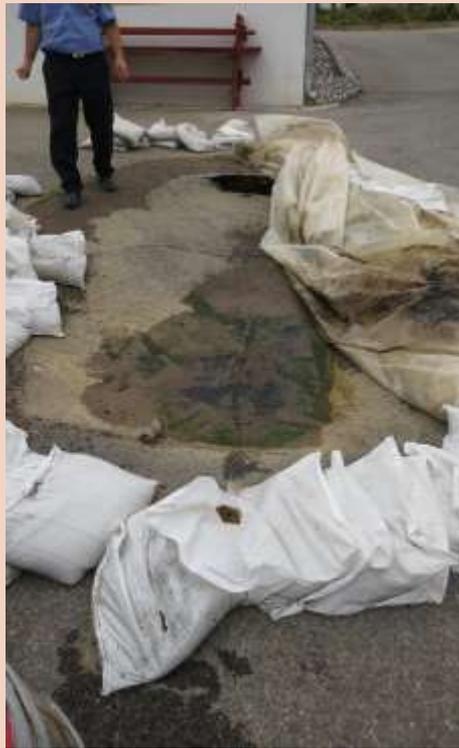
Changes in drainage capacity of originally unpaved roads in heavy rain situations

The extensive use of asphalt and cement as paving materials for roads can, in particular cases, induce dramatic changes in the paths of rainwater streams and lead to sudden failures. In this example, repeated heavy rain periods induced the washing off of soil underneath the asphalt and consequently the collapse of the road. Asphalt roads have a considerably lower water permeability capacity than older unpaved tracks and such aspect should be closely considered especially in situations in which asphalt can be avoided (e.g. pedestrian roads)

Collapse of a pedestrian road section due to soil removal by rainwater (Baranya Co./Hungary).

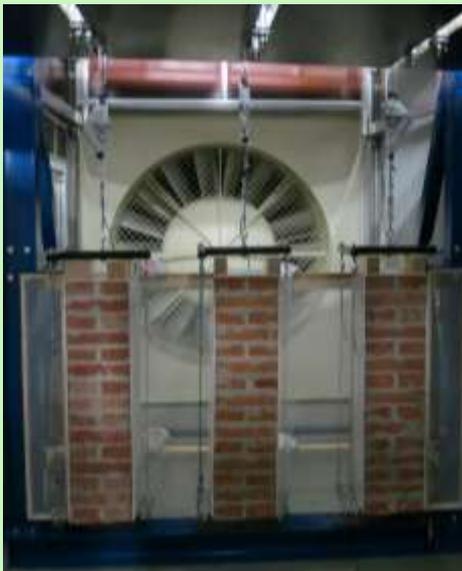
Brick masonry testing of wind-driven rain (CET, Telč, CZ).

Investigation of the performance of building components/interventions against excessive rain penetration

In the perspective of improving the resilience of cultural heritage assets against heavy rain, it is important to investigate the performance of historical building components under strong rain loads as well as to evaluate the effectiveness of possible interventions. In the picture left, a rain penetration test of masonry pillars in the “Vincenc Strouhal” climatic wind tunnel in Telč, CZ. This is used to study rain penetration and its mechanical effects.

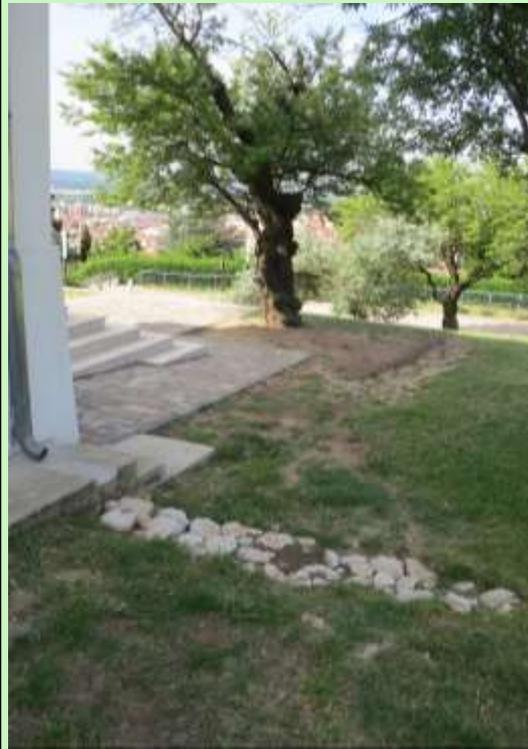
New drainage system of a baroque church (Pécs, Hungary).

Design and implementation of adequate drainage systems

Existing drainage systems should be surveyed and repaired on a periodic basis. New systems, or parts of them, should be carefully designed to allow for the increased rain loads, in case the existing system is deemed not sufficient. In this example, drain pits have been added to the system in order to stop the flowing of water downhill (notice the erosion of the ground due to rain before interventions).

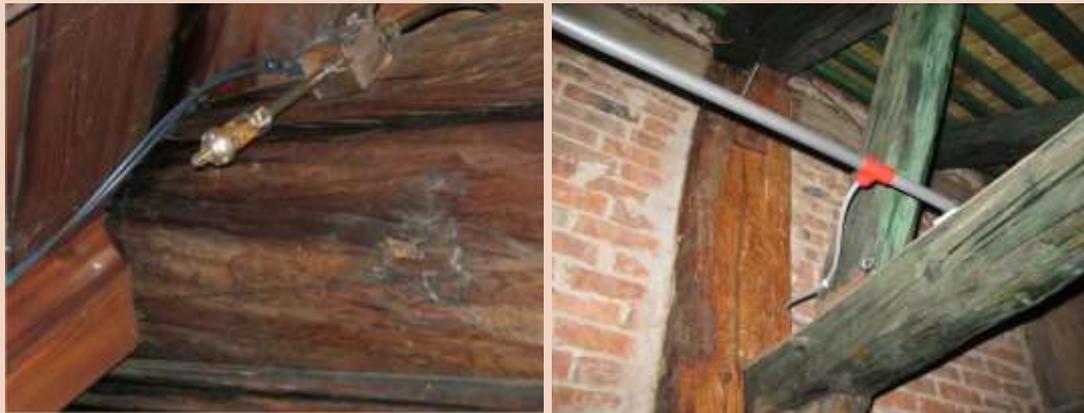
World Heritage Church (Wojanow/Poland)

Visual impact of fire-fighting systems

The visual impact of fire-fighting systems is quite variable depending on its type and location within the building. Often such systems have an acceptable impact on the overall appearance of building components. In the picture left, for example, it is shown a nozzle for high pressure mist fitting harmoniously in the context in which it is placed. In other cases, particularly in hidden spaces, systems can be more intrusive. This is seen in the picture right, which shows water supply pipes in the roof space of the World Heritage Church, Wojanow (Poland).

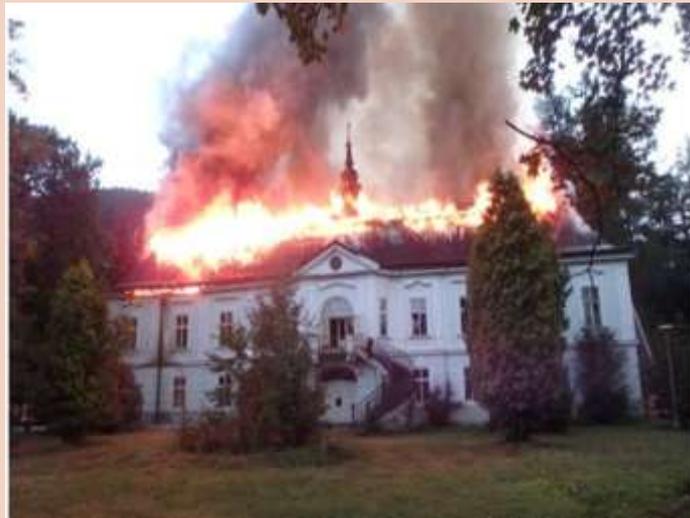
Horní Maršov (CZ)

Lack of crime prevention

Nowadays, most of cultural heritage objects are still lacking protection against acts of vandalism and theft. Specifically connected to fire, it should be mentioned that arson is one of the most frequent crime offence against cultural heritage. In this example, left Chateau Horní Maršov (Czech Republic) damaged by fire started on several places under the roof due to activity of a group of arsons (August 2018). Below, left wooden church in Guty (Moravia) restored before fire (2014); on the right, the church totally destroyed in 2018.

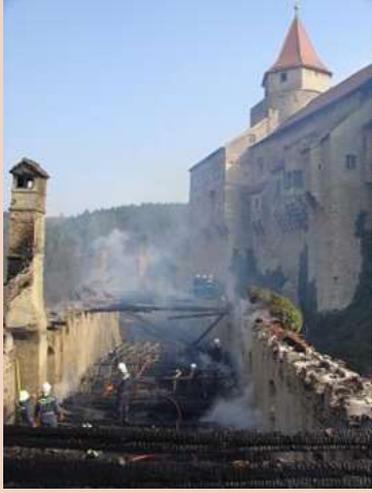
Pernštejn Castle, CZ

Negligence

Many fires start due to negligence of users or workers typically employed for repair and restoration or construction works. In the picture on the left, a medieval roof framework destroyed by fire during repair intervention.

[18] Kasal, B., Kloiber, M., Drdácý, M.: Field Investigation of the 14th Century Castle Pernstejn before and after Fire Damage, in *AEI Building Integration Solutions, Proceedings of the 2006 Architectural Engineering National Conference*, 29.3.-1.4. 2006, Omaha, Nebraska, USA, ISBN 0-7844-0798-3, p.70, 2006

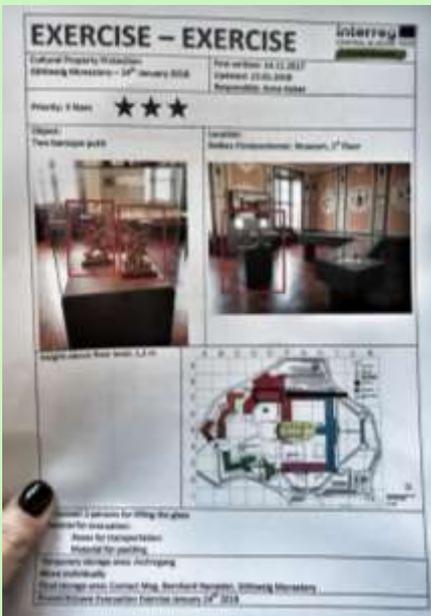
Götweig Monastery exercise, Austria (DUK University)

As for any other type of hazard, practice drills and rescue exercises should be periodically carried out involving a number of different stakeholders commonly involved with cultural heritage protection as well as the civil society, whose active participation in case of disaster can significantly increase the resilience of the assets.

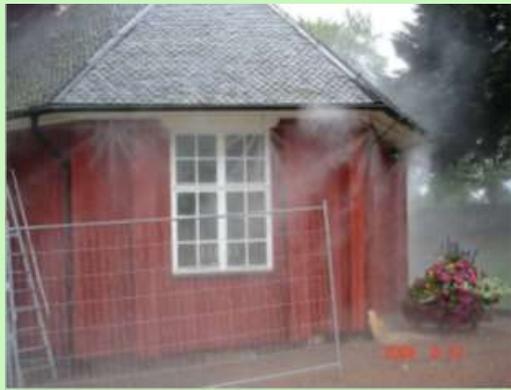
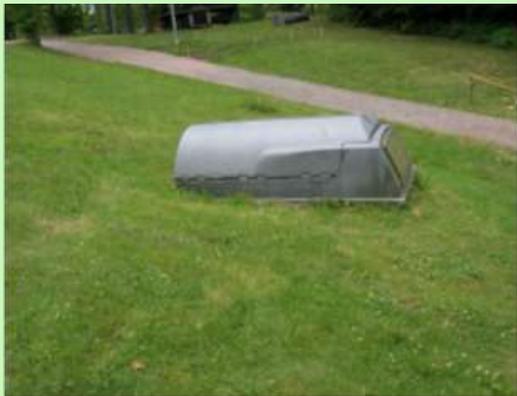
Implementation of automatic fire-fighting systems

Automatic fire-fighting systems are extremely important in protecting cultural heritage assets from fire. These should be carefully designed and implemented in order to minimise the impact but at the same time ensure that the necessary level of safety is provided. In the pictures: (above) automatically starting high pressure mist sprinklers in action, (below) water gun with automatic starting of operation upon signals from sensors of the electronic fire signalization system.
