# D.T2.7.1 FINAL SELF-EVALUATION REPORT

RAINWATER HARVEST AND GREYWATER REUSE BUDAPEST ZUGLÓ, HÉTSZÍNVIRÁG KINDERGARTEN Version 2 05 2022

Prepared by Zugló Municipality

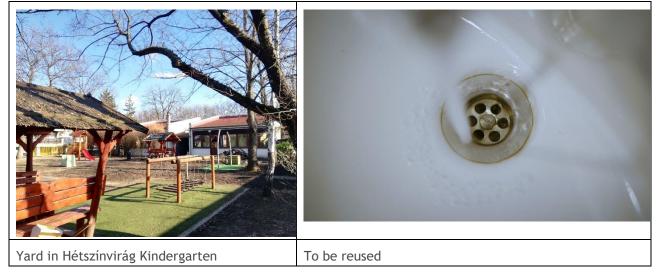
Rainwater & greywater collection and reuse system

The rainwater run-off is harvested by 5 gutters from a 200 m2 section of the roof. Solid contamination (mainly leafs) are filtered by a filter chamber, unloaded manually.

The greywater from the handwashing units of the nursery are collected and drained in the same system.

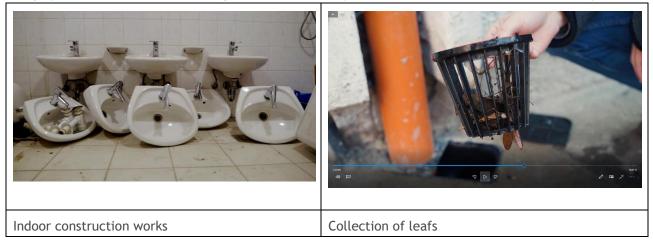
Supplies	Gravel bed

The two water sources (rainwater and greywater) are drained to a pre-filtration zone: a waterproof ditch, filled with fractions of different sized gravel and planted with herbs. The gravel and roots perform the filter effect.

The pre-filtered water is collected in two, 7 m3 (14 m3 in total) capacity tanks sunk into the ground in the courtyard.

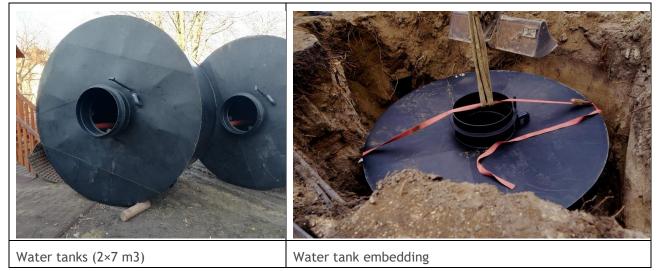
Indoor construction works	Indoor construction works

This purified and stored water is reused in two ways:

A part of it is used for flushing the toilets in the building. Currently 8 toilets are connected to the greywater system. The wastewater from the toilets (blackwater) will follow the "traditional route" into the public sewer.

The other part of the collected water will be used to irrigate the garden.

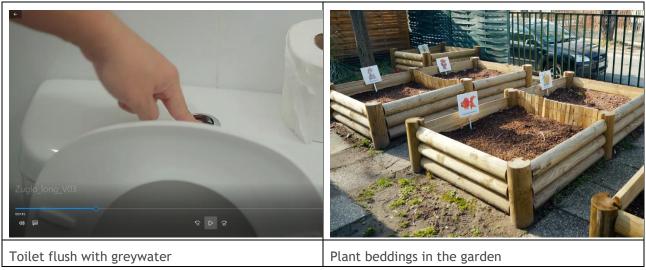
If the 14 m3 storage capacity is not sufficient, for example in a persistent heavy rainstorm, the excess water can be simply discharged into the public sewer. If there is too little greywater and rainwater collected from the roofs and handwashing taps, the water tanks are filled with drinking water from the city water network. Due to the lack of the automatic refill system, it needs manual interventions.

Additional works in progress: automatic refill system planting and garden reconstruction water retention with rain gardens: garden in a container system
