-   Peer review meeting, City of Bydgoszcz, 11 April 2022 r.
-

**Rainwater utilisation via rooftop rainwater harvesting serving rain gardens in Bydgoszcz**
Pilot investment - rain garden at City Hall, 9-15 Grudziądzka Street, Bydgoszcz
-   CWC City Water Circles, B. Katarzyna Napierała

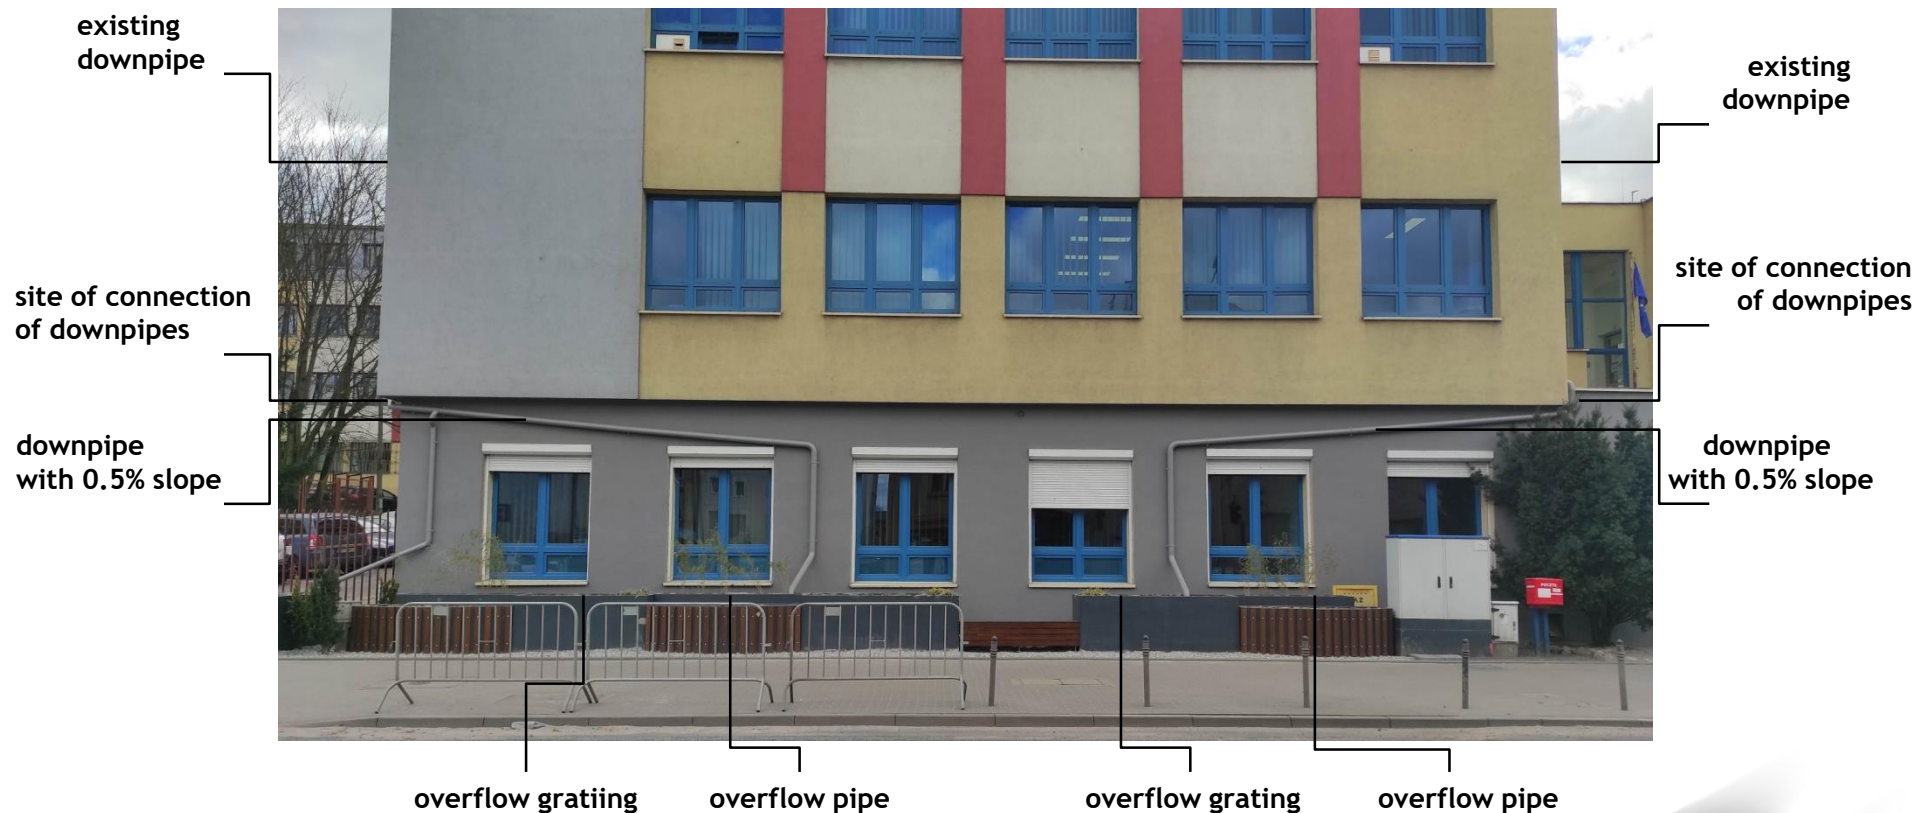
Diagram: location of downpipes, overflow pipes and overflow gratings

RECONSTRUCTION OF RAINWATER SYSTEM

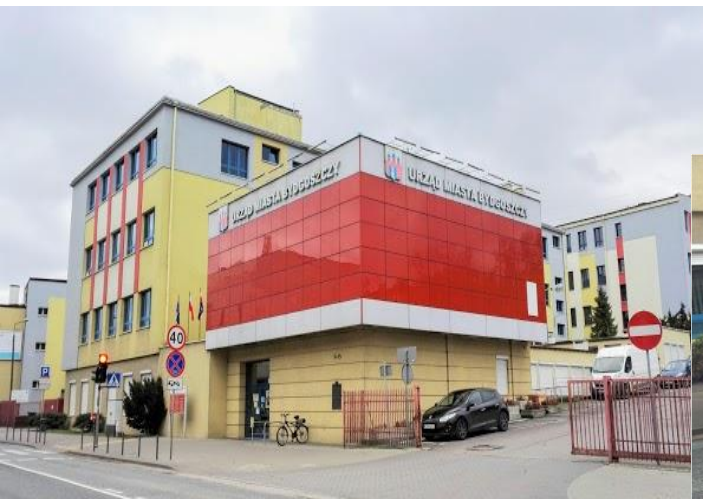
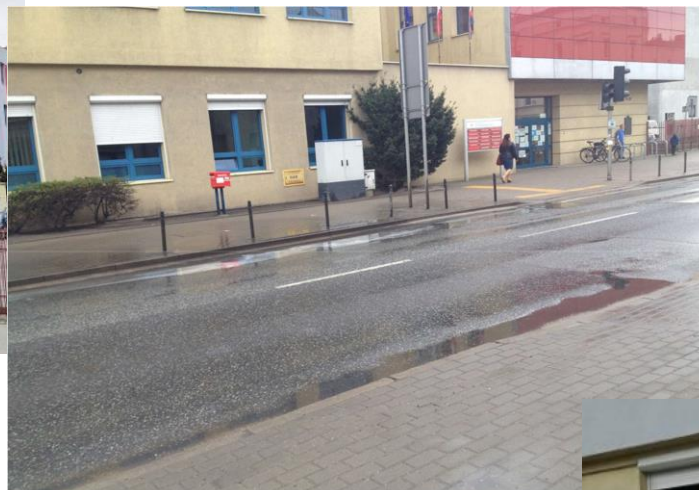
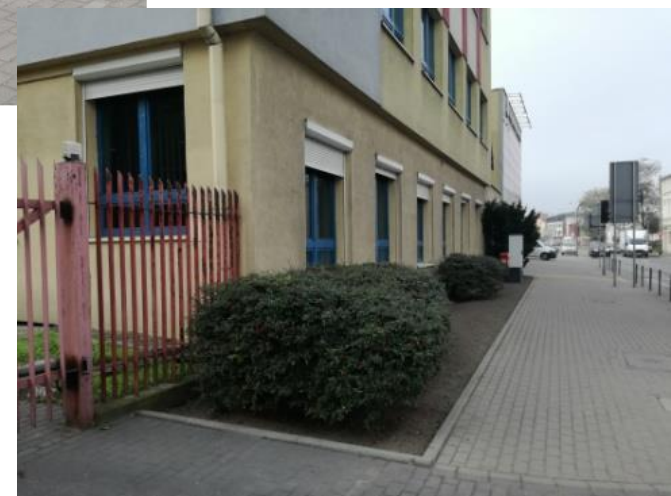
prior the construction

LOCATION BUILDING A OF THE CITY HALL, 9-15 GRUDZIĄDZKA STREET

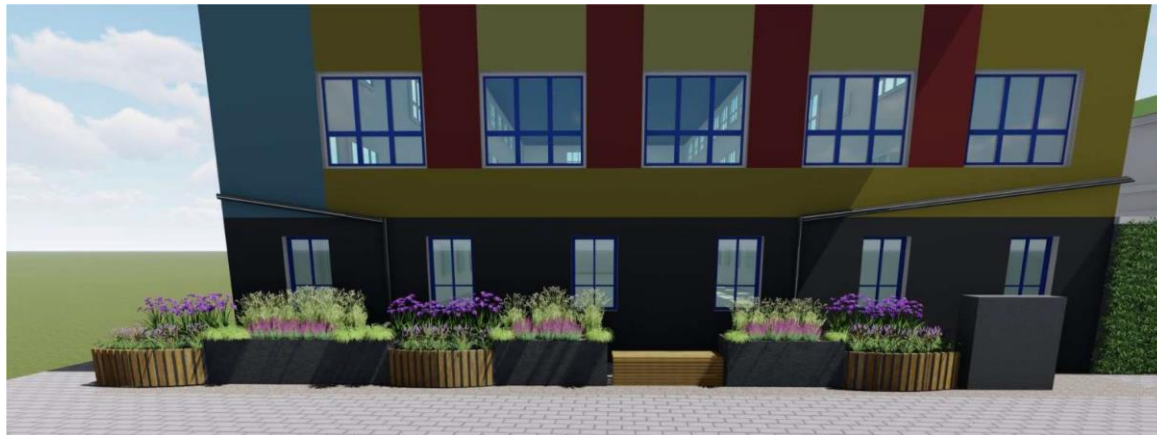
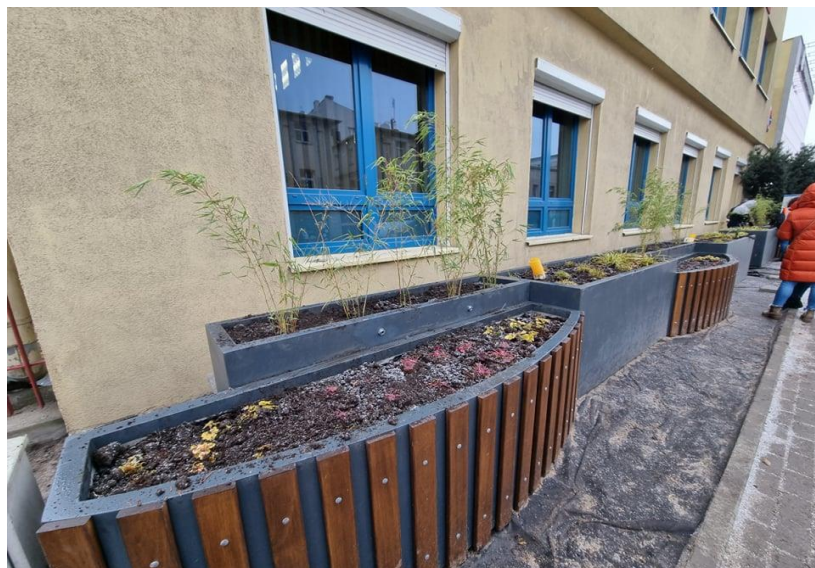
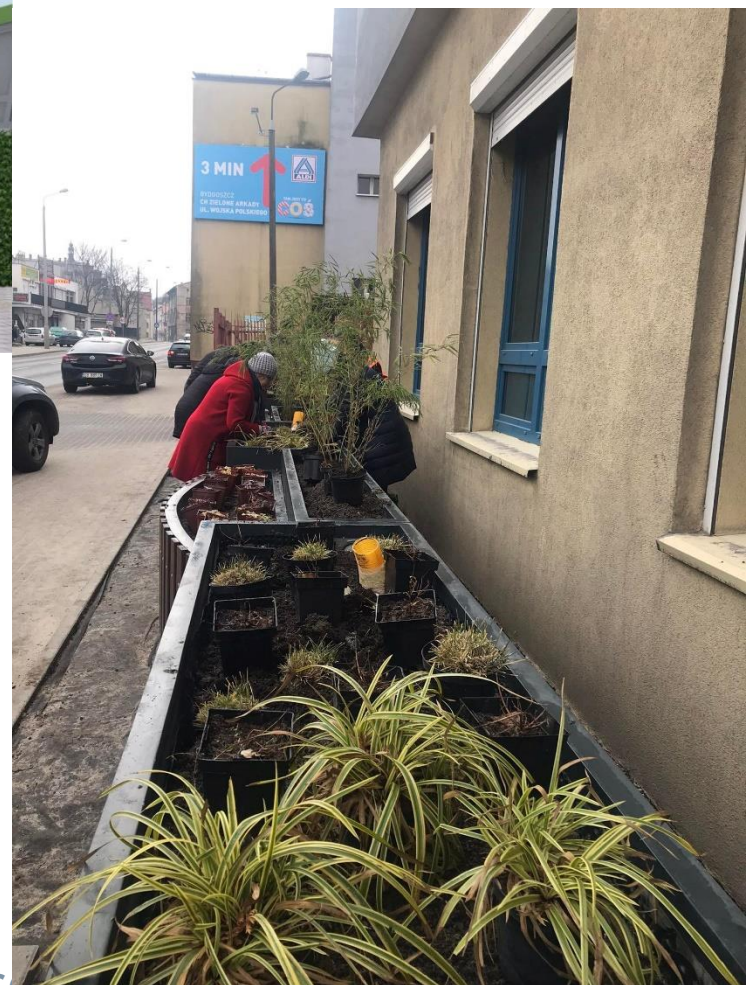
after construction

LOCATION BUILDING A OF THE CITY HALL, 9-15 GRUDZIĄDZKA STREET

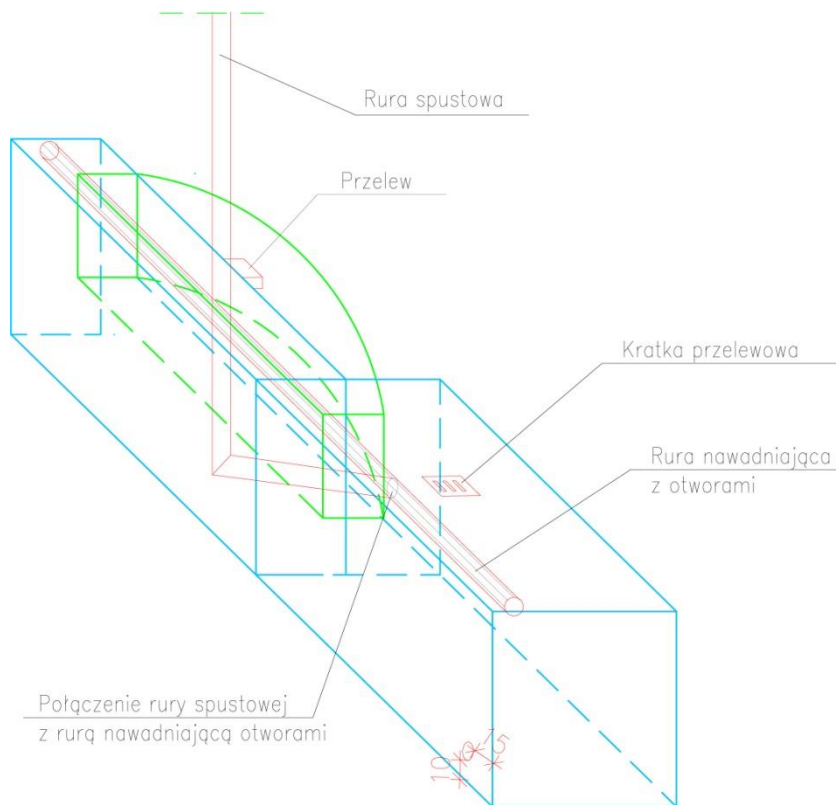
Fig. 1 Watering

RAINWATER MANAGEMENT SYSTEM

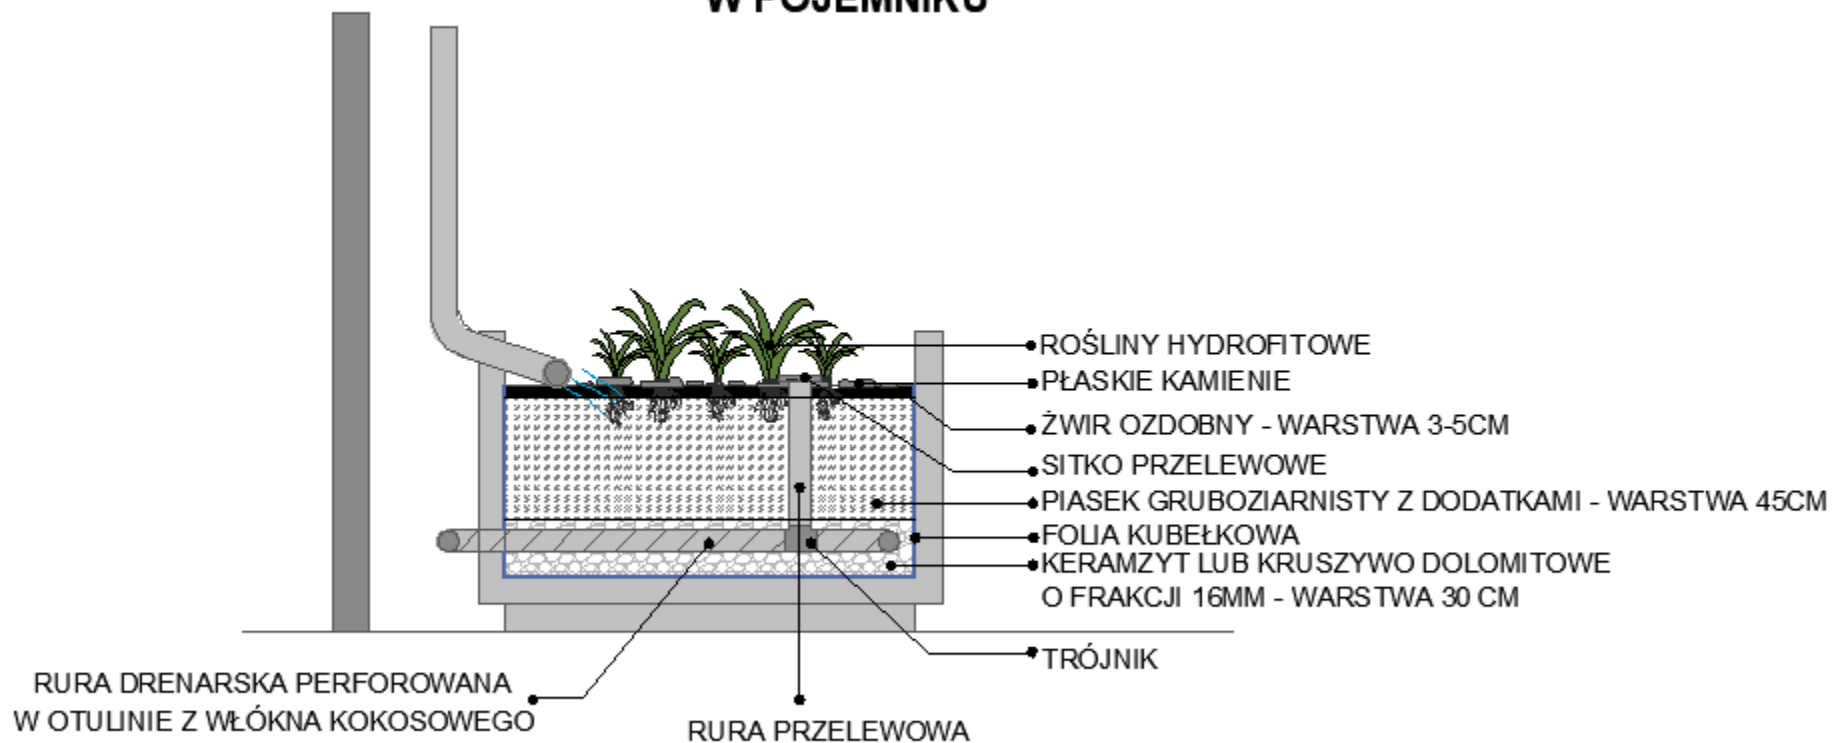
- CROSS-SECTIONAL DRAWING OF A RAIN GARDEN IN A CONTAINER

CONSTRUCTION OF RAIN GARDEN

SCHEMAT PRZEKROJU OGRODU DESZCZOWEGO W POJEMNIKU

Description of solution	Total retention capacity of rain garden [m ³]	Rain garden area [m ²]	Total dimensions of rain garden [m]
Rain garden in containers	~ 3,37	12	12,00 x 1,00 x 0,85

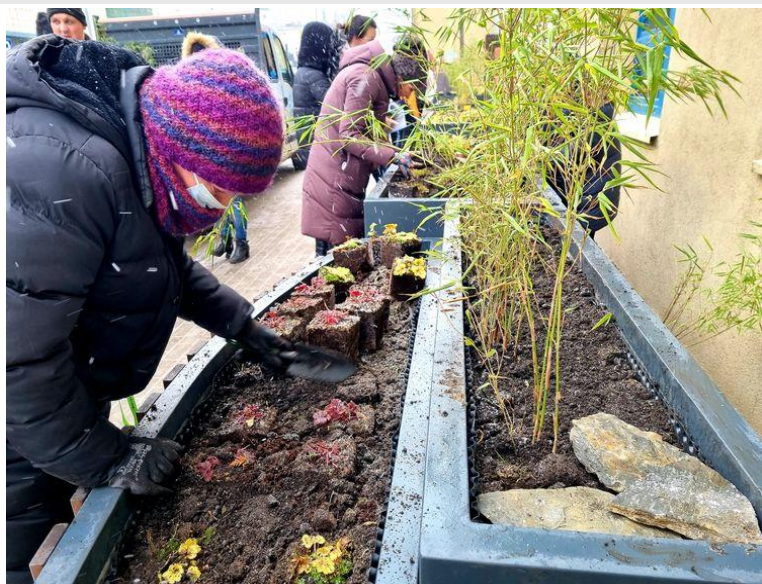
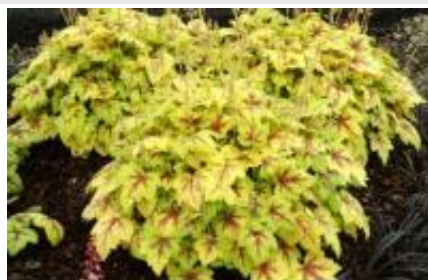
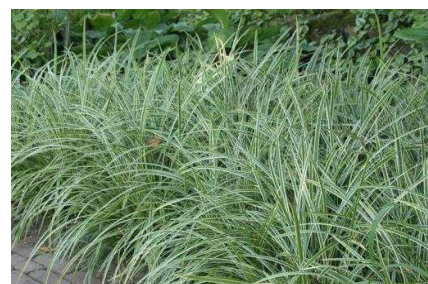
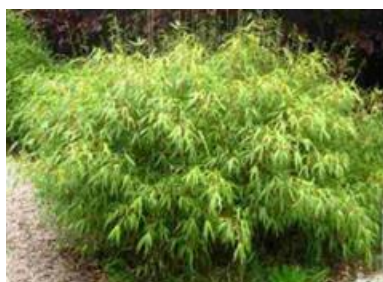
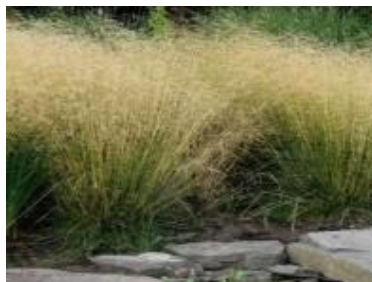
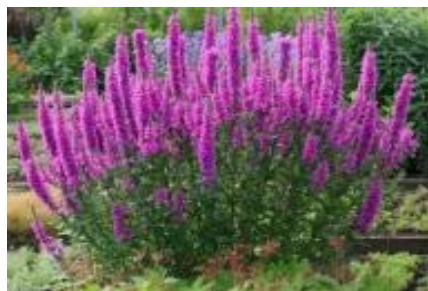
Rys. Projekt nasadzeń

- ❖ Bambus mrozoodporny „Volcano”
Fargesia nidida
- ❖ Turzycza Morrowa ‘Ice Dance’
Carex morrowii
- ❖ Śmiątek darniowy
Deschampsia cespitosa
- ❖ Krwawnica pospolita
Lythrum salicaria
- ❖ Żurawka
‘Fire Chief’, ‘Electra’
Heuchera

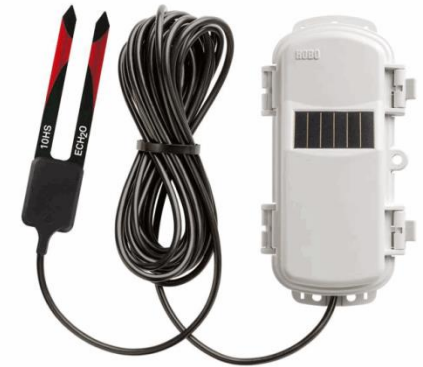
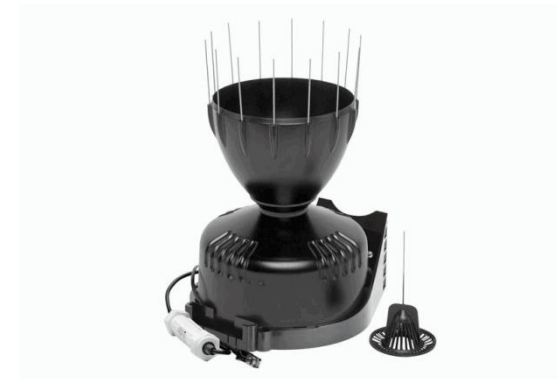
- Compact weather station with built-in solar panel for long-term monitoring of environmental measurements via GSM network
- 4 sensors measuring soil moisture, designed to work with a wireless network
- Rain gauge - intelligent hourglass precipitation level sensor
- The meteorological station will be mounted on the wall of City Hall building A.

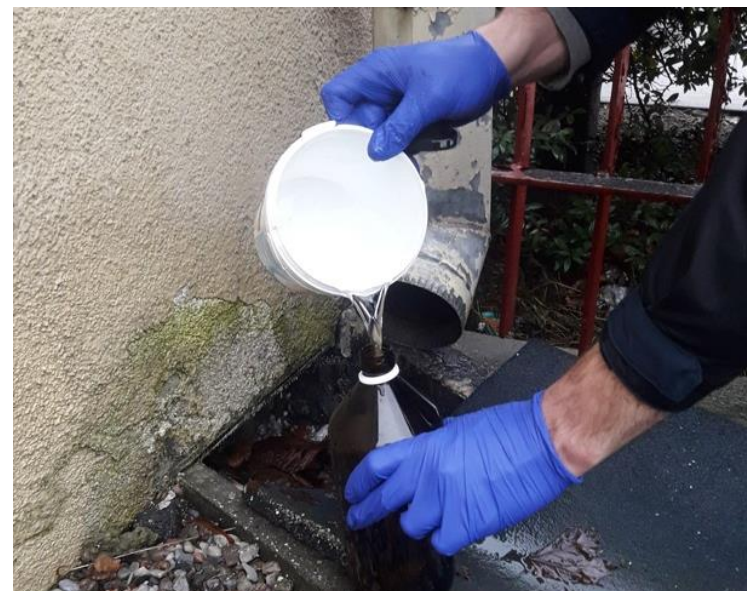
PHYSICO-CHEMICAL AND MICROBIOLOGICAL PARAMETERS

: Total Suspended Solids (TSS)

- Biochemical Oxygen Demand (BOD5)
- Oxygen concentration
- pH
- Coliform bacteria, Escherichia Coli
- Faecal Enterococci
- Polycyclic Aromatic Hydrocarbons (PAHs)
- Conductivity
- Dissolved organic carbon

The physico-chemical parameters are within the existing, or no longer valid, norms for bathing water and do not raise any objections to using rainwater for irrigation of rain gardens. However test results indicate exceedances for faecal enterococci (roof contamination with organic matter of animal origin).

The use of rainwater does not present a risk to human health as it will not be used for watering edible plants and will not be sprayed.
